SERVICE BULLETIN

PRODUCT JH-110 RECORDERBULLETIN NO. 202**SERVICE BULLETIN**DATE APRIL 29, 1976P.C. BD. POWER HARNESS No. _____ECO NO. 162 IN NEW PRODUCTION April 20, 1976

PRODUCT JH-110 RECORDER

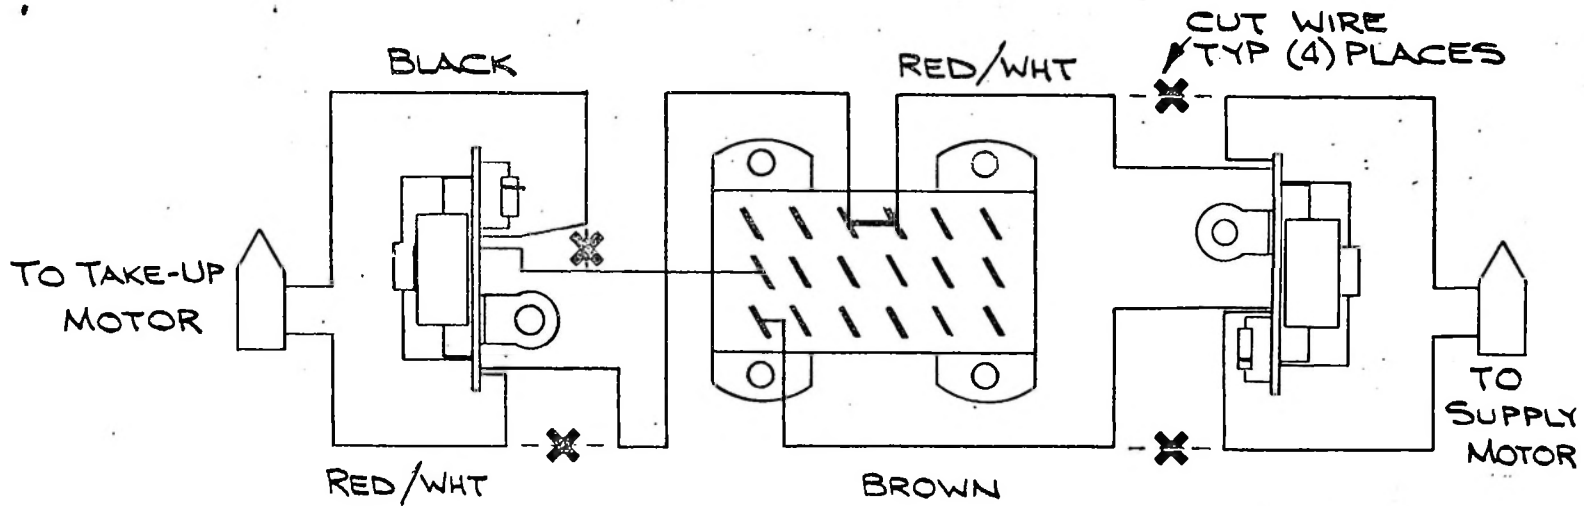
FIG 4

To prevent accidental shorting of motor supply leads.

1. Remove Power Cable from Power Supply and Transport. Open MALE END. Clip out the component assemblies. (There are two assemblies similar to Fig. 1 on the reverse side of this page.) Reassemble the plug.
2. Drill two holes in the Deck Electronics Chassis - one on each side of the Power Plug. (See Fig. 2 for the correct positions) Holes should have clearance for a 4-40 screw.
3. Mount the two sub-assemblies (Fig. 3) with the large components turned AWAY FROM the power plug. (See Fig. 4)
4. Unplug the connector to the Supply motor. Cut both wires and reconnect as shown in Fig. 4. Replace the Supply motor connector.
5. Unplug the connector to the Take-up motor. Cut both wires and reconnect as shown in Fig. 4. Replace the Take-up motor connector.

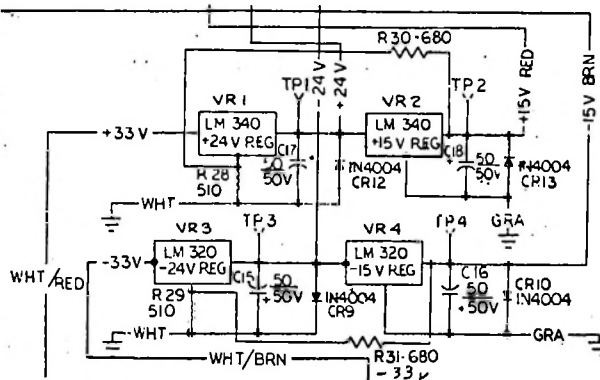
To improve reliability of the 24v regulator circuit.
To stop destruction of 24v regulators in short circuit mode.

1. Remove CR8 and CR11 (In5238)
2. Add a 680 ohm $\frac{1}{2}$ watt resistor from the output leg of VR2 to the reference leg of VR1.
Add a 680 ohm $\frac{1}{2}$ watt resistor from the output leg of VR4 to the reference leg of VR3.
Add a 510 ohm $\frac{1}{2}$ watt resistor from the reference leg of VR1 to ground.
Add a 510 ohm $\frac{1}{2}$ watt resistor from the reference leg of VR3 to ground.

The new schematic will be:

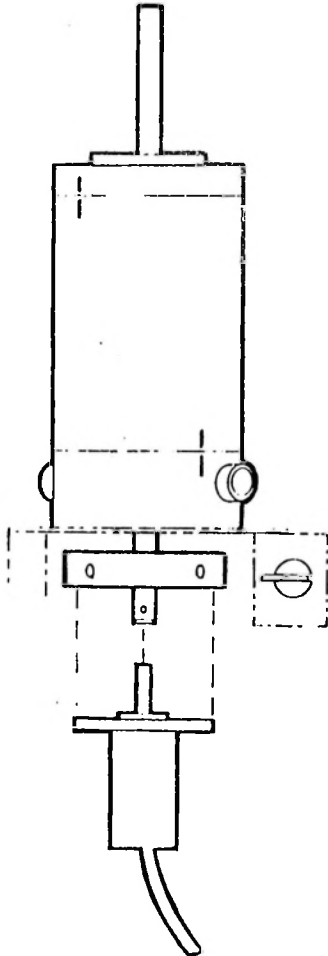
WARNING: In the following steps, do NOT ALLOW the strong magnetic field to pull the housing into contact with the bearing or the shaft.

IF THE MAGNETIC HOUSING TOUCHES THE SHAFT OR BEARING, THE TAPE SPINDLE WILL BE MAGNETIZED. IT IS DIFFICULT TO DEMAGNETIZE,

STUDY THE SKETCH BELOW BEFORE CONTINUING WITH THE DISASSEMBLY.

Form a "CONE" with the fingers of the left hand over the motor shaft. The purpose of this "cone" is to keep the magnet housing from TOUCHING the bearing or the shaft.

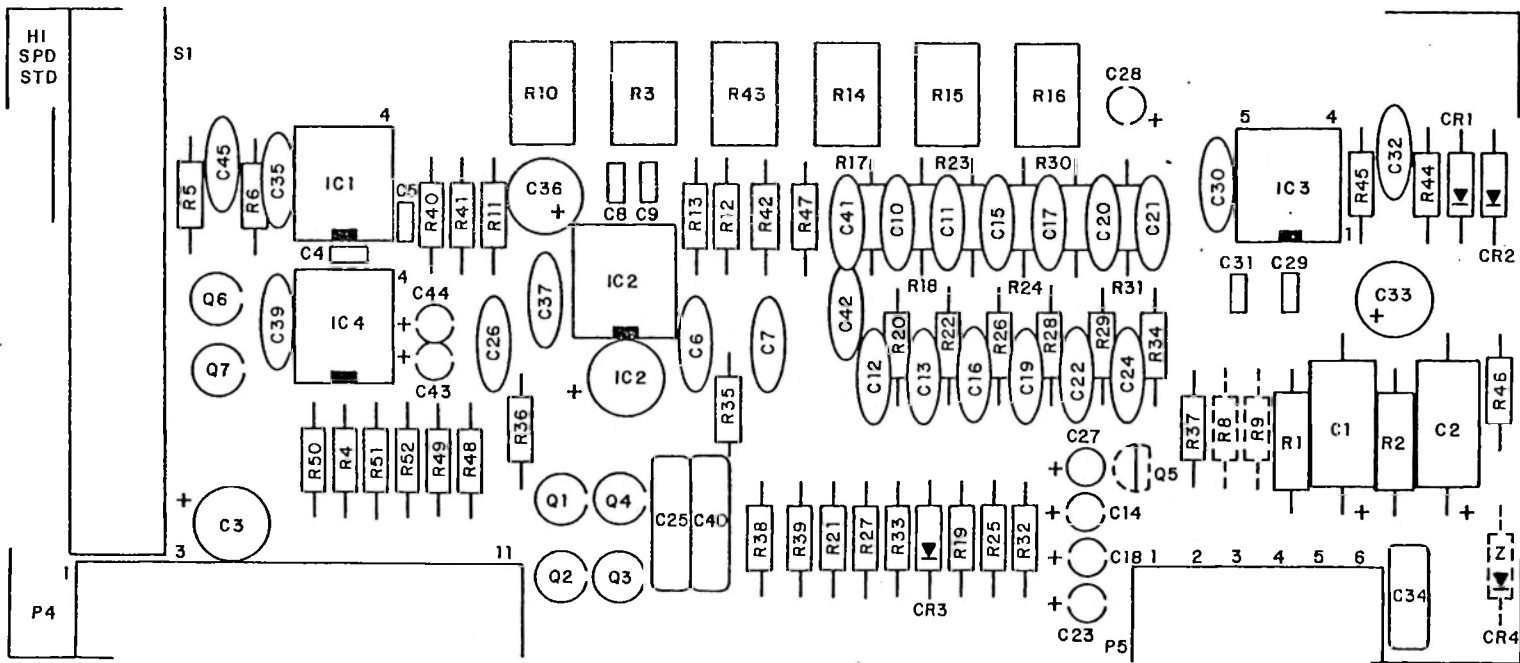
SS 2700C0914 - 00B
 RECORD BD
 STD & BDCST

Re-installation of Linearity Control on Record Bd. useful on certain tape formulations.

MCI has found that the Linearity Control is useful with tapes such as Scotch 250. However, the pot has no measurable effect on Ampex 456.

- Step 1) Remove Jumper between R43-CW and R43-S
- Step 2) Remove Jumper at CR1
- Step 3) Install a 2K ohm 18T Side Adj. Pot at R43
- Step 4) Install 2- 1N34A Diodes at CR1 and CR2
- Step 5) Delete label on card pull handle and replace with new label.

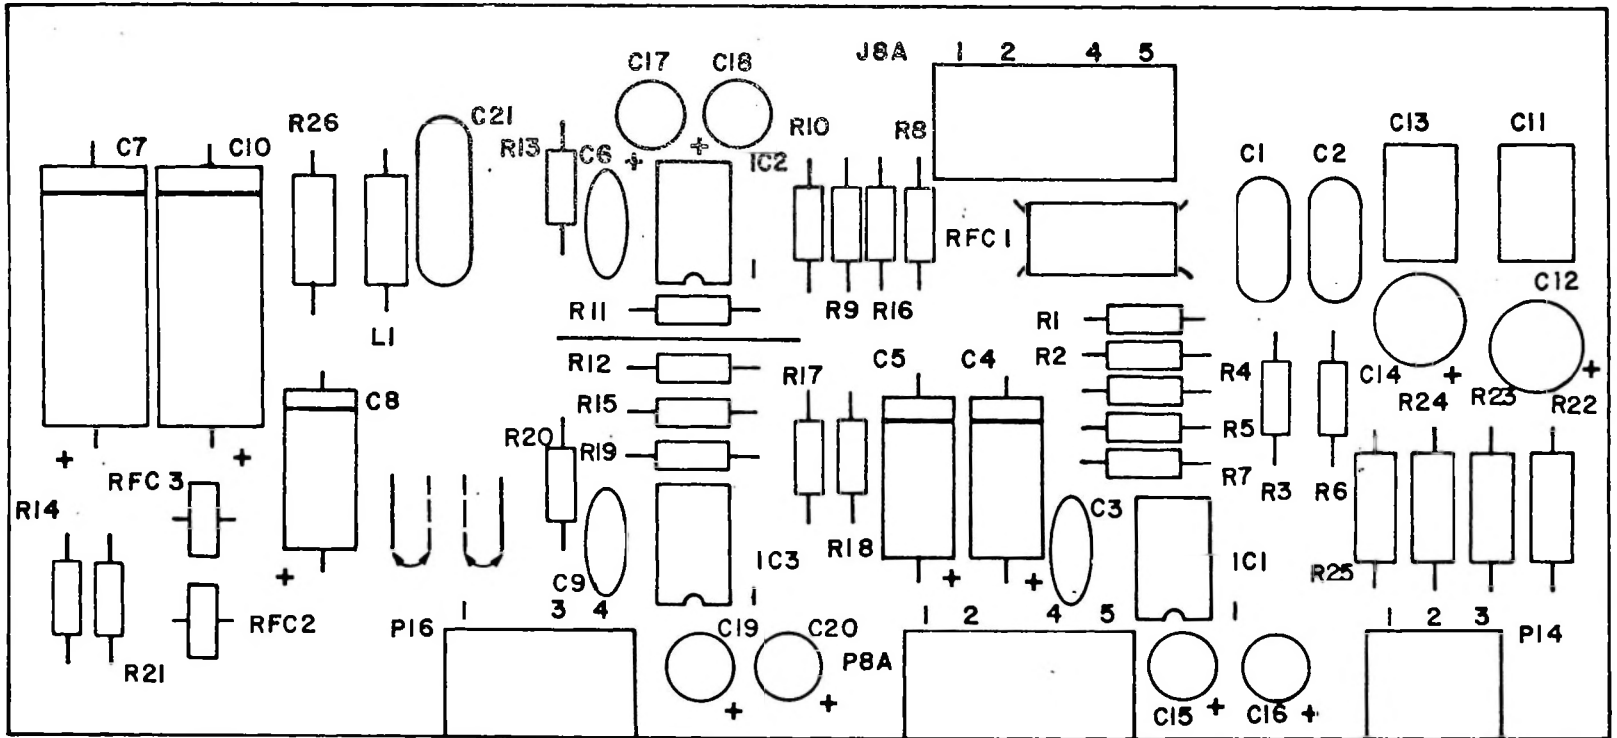
PC2700C0916-00B
 SILKSCREEN
 I/O CARD, JH110A

To correct phase error in I/O Amp Board that will be present in all modes.

Change jumpers on I/O Board as shown on reverse side.

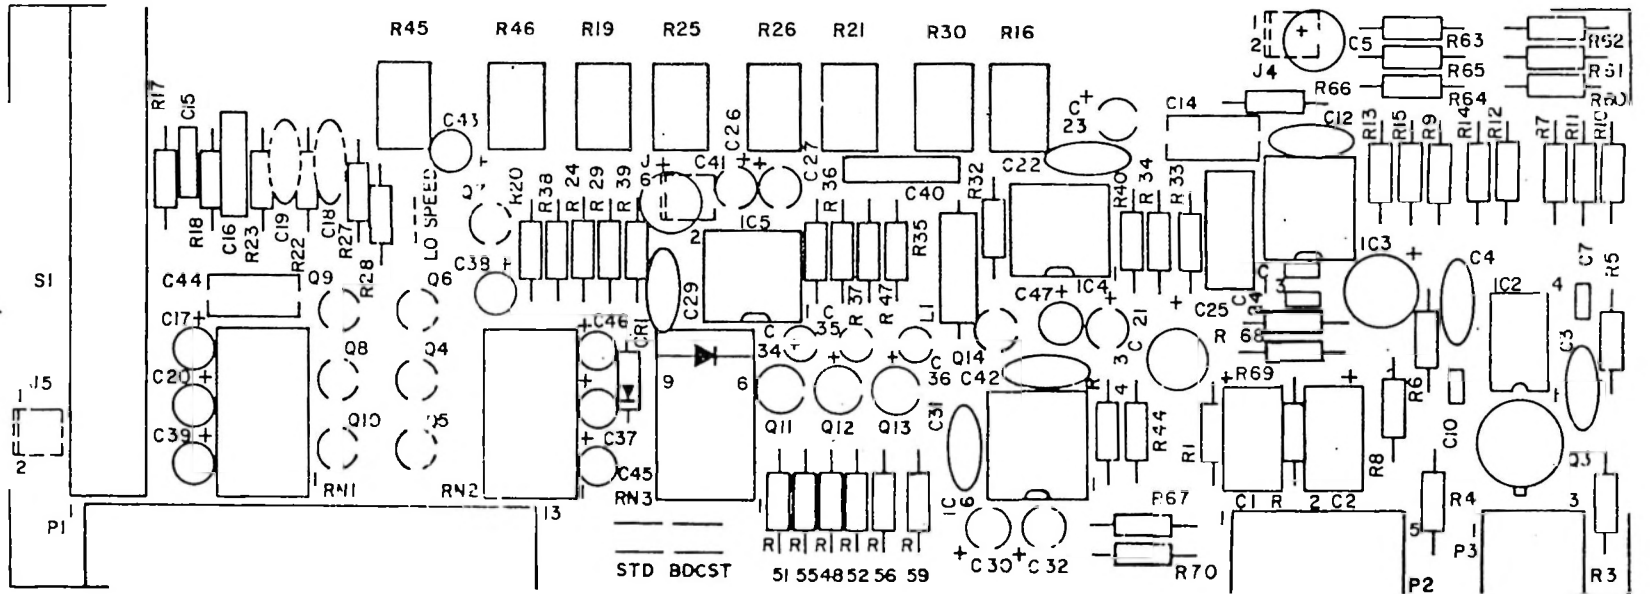
SS2700G0913-00J
 SILKSCREEN
 REPRO BD, JH-110A
 BDCST & STD

To correct monitor punch-in noise.

Add a 1N914 diode to RN3 from Pin 9 to Pin 6 as shown on drawing on reverse side.

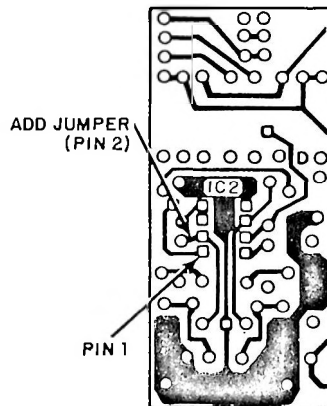
Missing land on art work. This land is a connection for the HF compensation cap. This could cause possible oscillation of the Input Amplifier. (IC2)

Add wire between pad and pin 2 of IC 2 as shown on illustration below.
