**SONY**  
Broadcast

This bulletin identifies recommended tools and alignment fixtures for the BVU Series Broadcast VTRs.

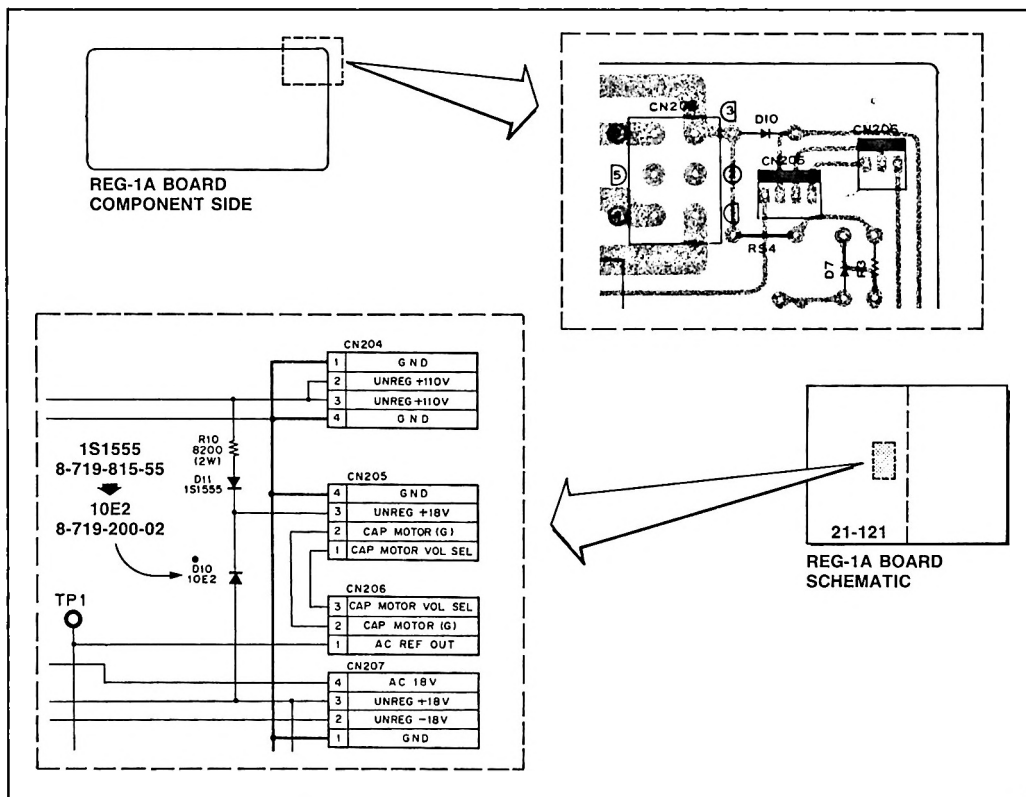
Figure 1

Diode D10 on the REG-1A Board has been changed in units with S.N. 20,101 and higher to increase the reverse voltage rating. This modification applied to earlier units will prevent damage should the 18V line of the Switching Regulator open.

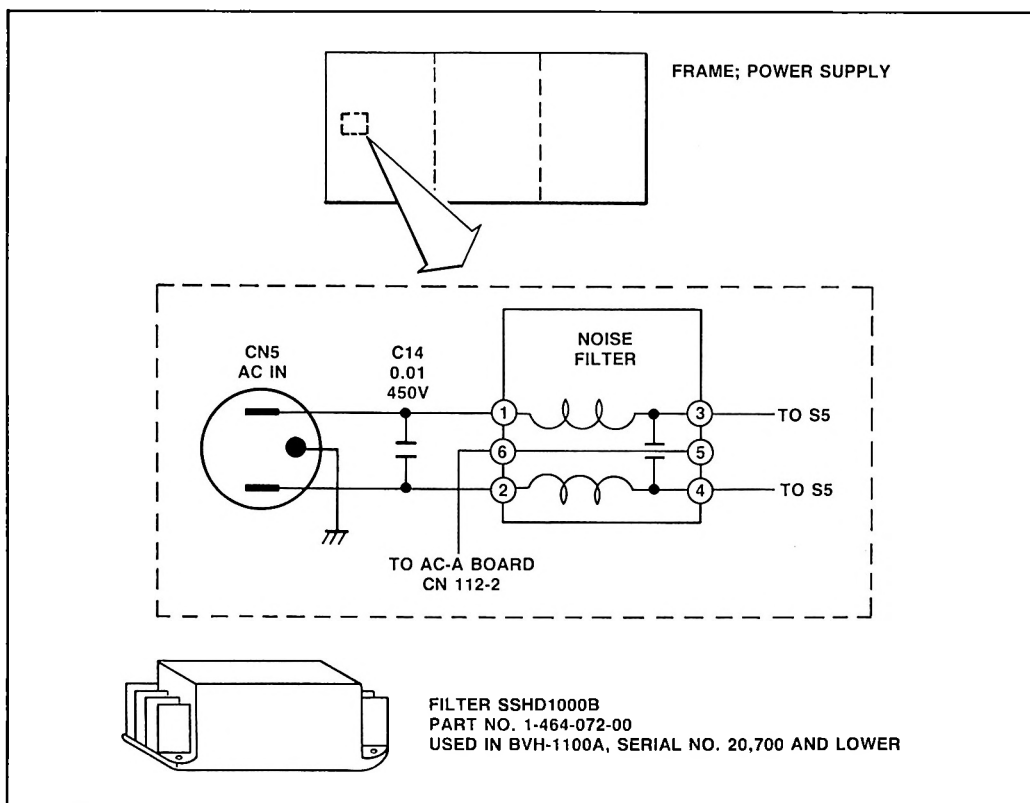
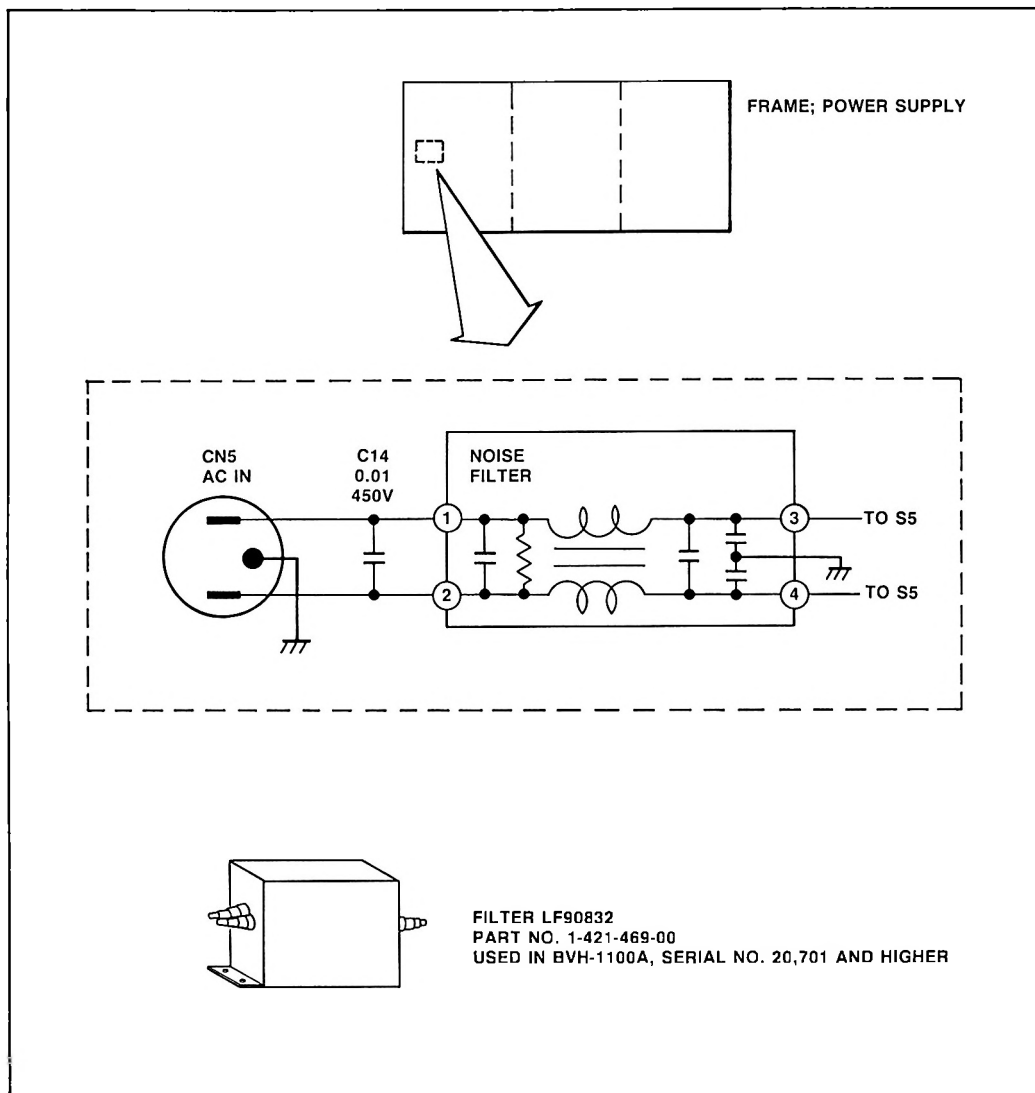
**Figure 1**

The power supply noise filter used in earlier models is not interchangeable with the filter used in later production runs. Be sure to use the appropriate part number if a replacement is needed. (See Figures 1 & 2.)

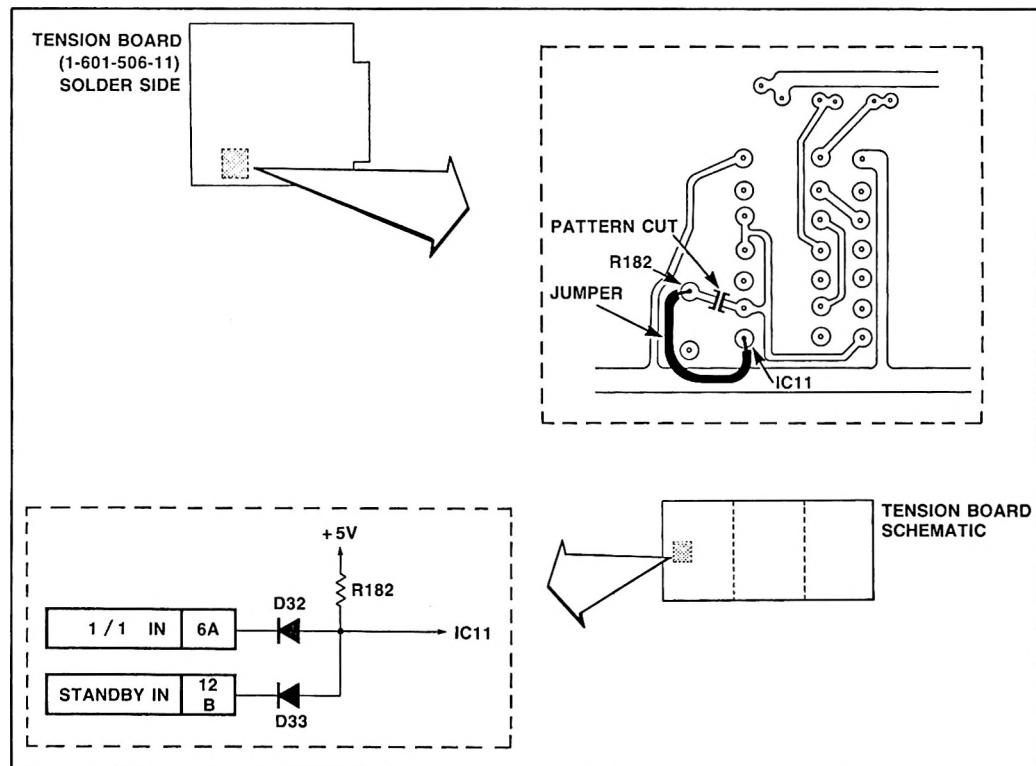
In the units listed above, an incorrect etching pattern on the Tension Board may cause malfunction of the Tension Motor drive circuits. The problem is a missing connection to +5V for pull-up resistor R182 (Figure 1). Tension motor drive is generated by NAND Gates in IC11. These gates are enabled by the output of AND Gate D32/D33. With no pull-up connection the output of D32/D33 becomes unstable when the inputs are high, and IC11 may be switched off by noise. The pattern cut and jumper connection shown in Figure 1 will eliminate the problem.

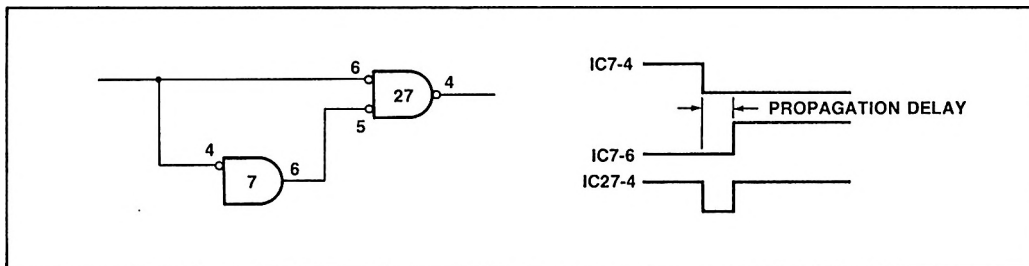
Figure 1

This modification is applicable to serial numbers 10,600 and lower. During the REVIEW mode the output from Audio-3 may be muted for 8ms at either the "In" point or the "Out" point of the edit. This occurs because of a spurious pulse at IC27-4 which is caused by the propagation delay of IC7 (See Figure 1.) The effect of this pulse can be eliminated with the following modification. (See Figure 2.)

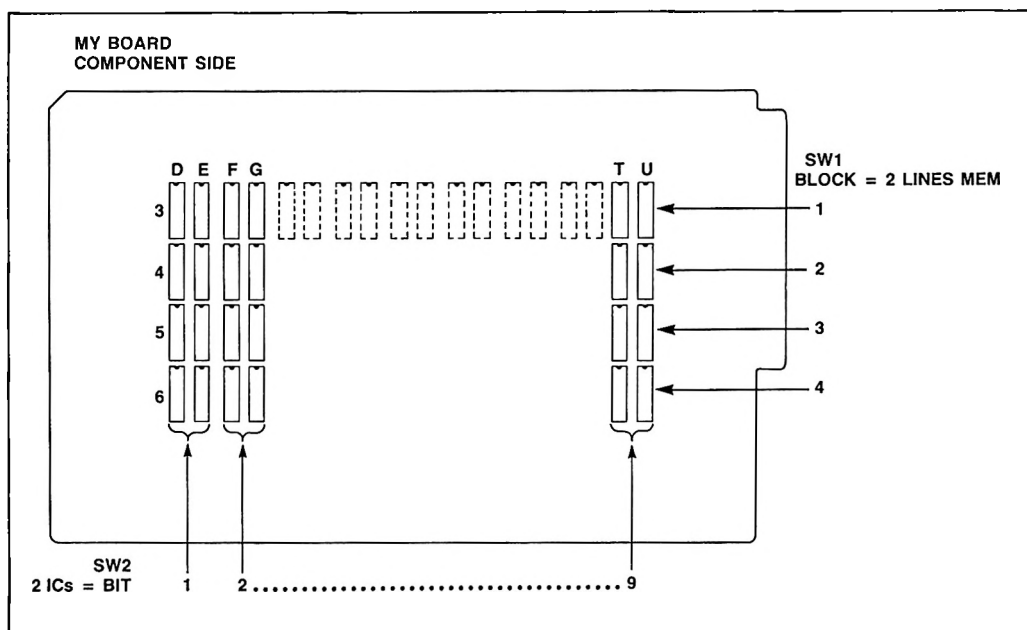
Figure 1

Test switches S1 and S2 (location T8 and K8 respectively) are installed on the MY Board for troubleshooting defective memory ICs. S1 provides a MEMORY READ (LINE) INHIBIT for each of four (2-Line) Blocks and S2 provides a MEMORY READ INHIBIT for each of nine (2-IC) Bits. (See Figure 1.) By sequentially switching S1 and S2 (as described in the following example) the location of the defective pair of ICs on the MY Board can easily be determined.

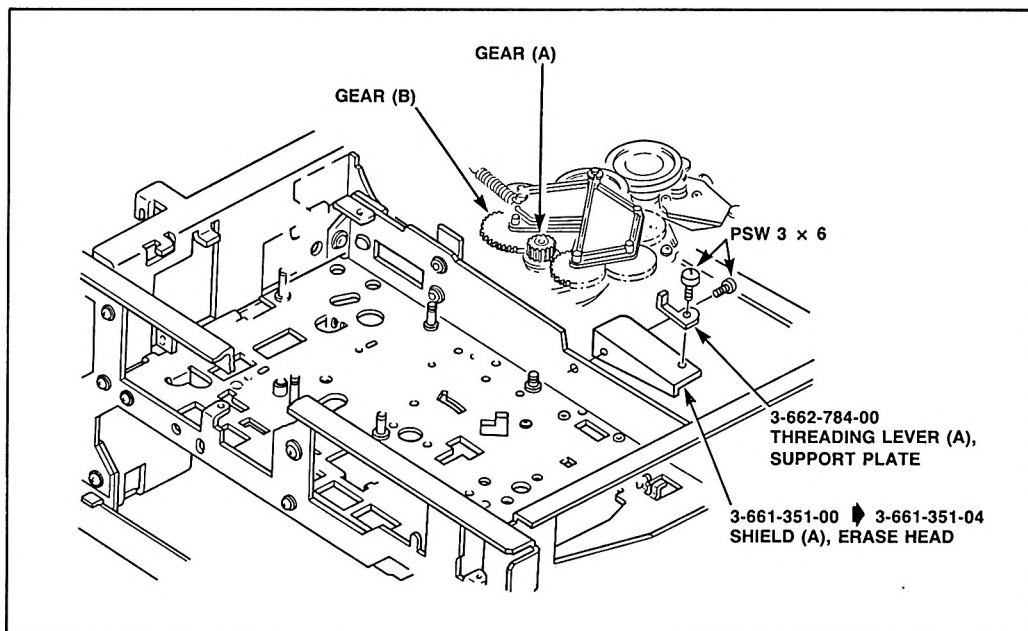
**Figure 1**

Support Plate Threading Lever (A) has been added to make the space between Gear (B) and Gear (A) adjustable. (See Figure 1.) This adjustment reduces gear noise during unthreading. Consequently, the Shield (A), Erase Head has been replaced and the *Threading Gear Position Adjustment* has been revised as described below.

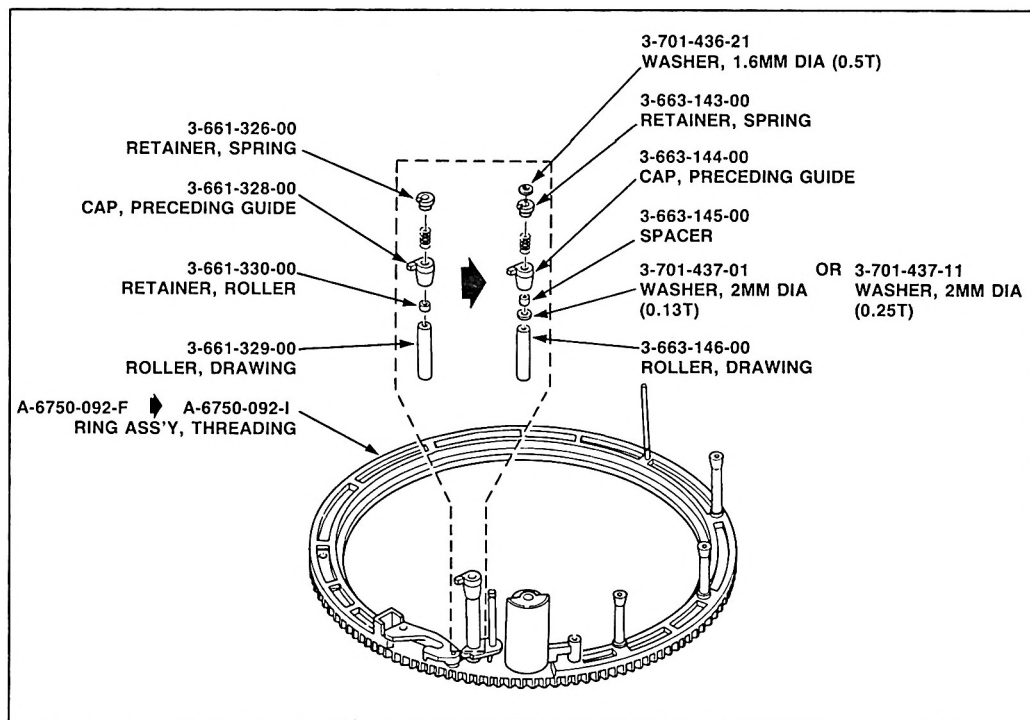
**Figure 1**

The Drawing Roller has been changed to make part replacement easier. (See Figure 1.)

- NOTE:** 1. Check that the thrust clearance of the Drawing Roller meets the required specification of 0.2 - 0.3mm.  
2. Adjust the clearance by adding or removing washer (2mm dia) P.N. 3-701-437(-01/-11).

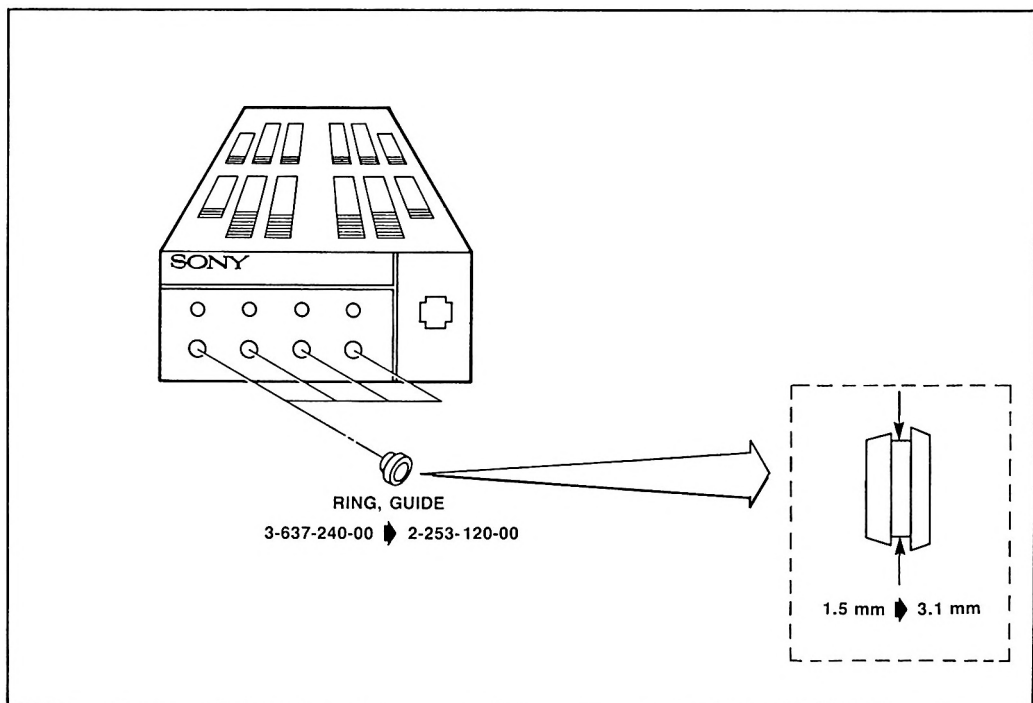
Figure 1

The battery connector guide ring has been changed in units with serial numbers 10,981 and higher. The new guide ring attaches more securely to the connector, eliminating the tendency for the part to come loose. The new part can be installed in units with serial numbers below 10,981.

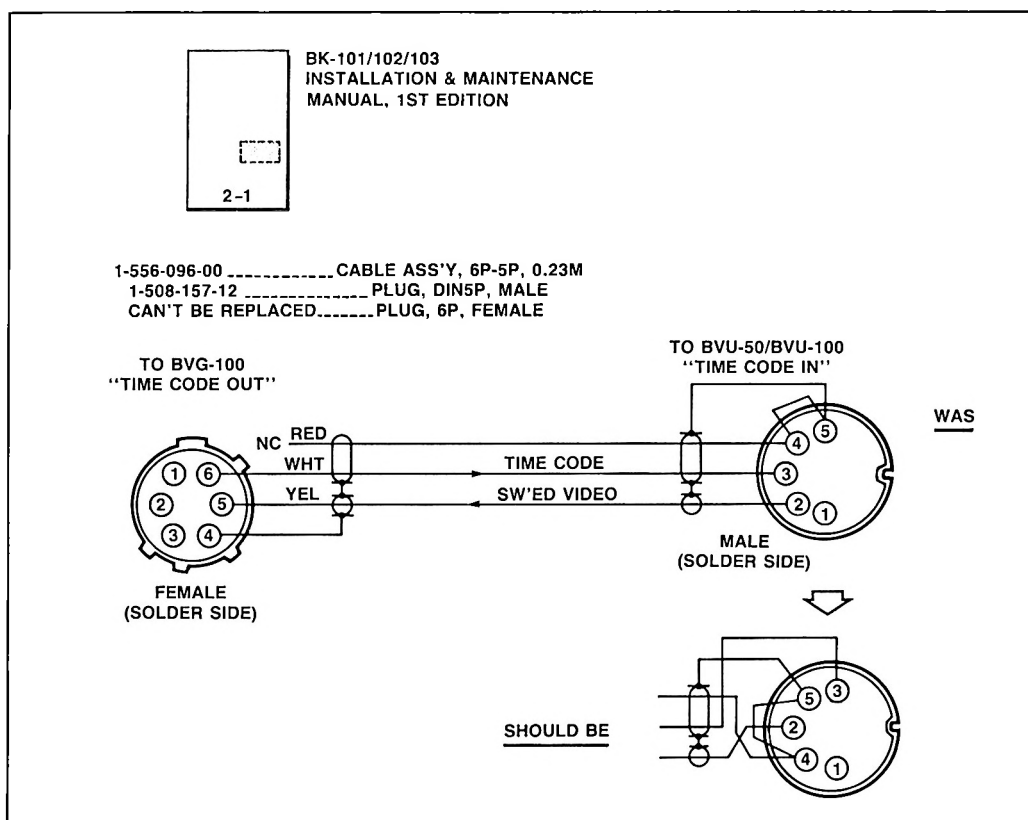
Figure 1

In the BK-101/102/103 Manual (1st Edition), pin assignments for the 6P-5P cable used in the BK-102 and 103 are in error. Please correct your manual as shown in Figure 1.

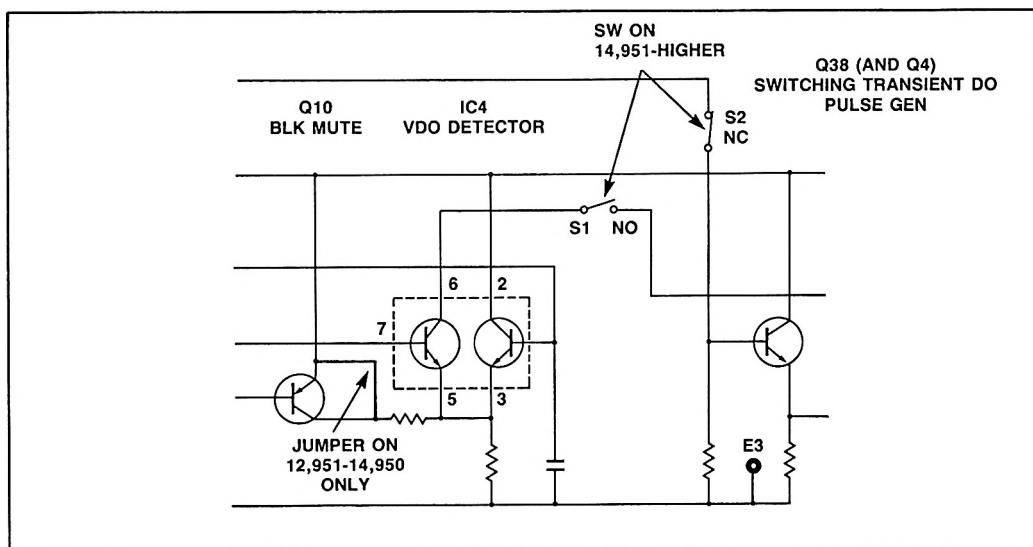
Figure 1

**NOTE:** On YD-8 Boards in units with S.N. 12,951-14,950, a jumper was factory installed between E and C of Q10. (See Figure 1.) With this jumper in place, the VDO Detector is disabled. Remove the jumper for transient suppression.

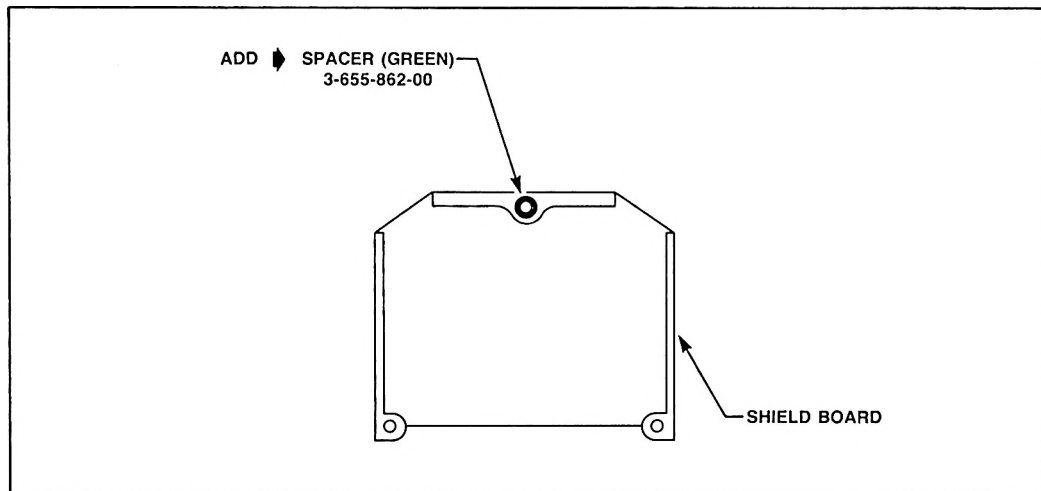
Figure 1

To prevent short circuits that may be caused by contact of Printed Circuit Board solder lines and/or component leads with the Shield Board, insert an insulating spacer as illustrated in Figure 1.
