## FAQ: VRC2000

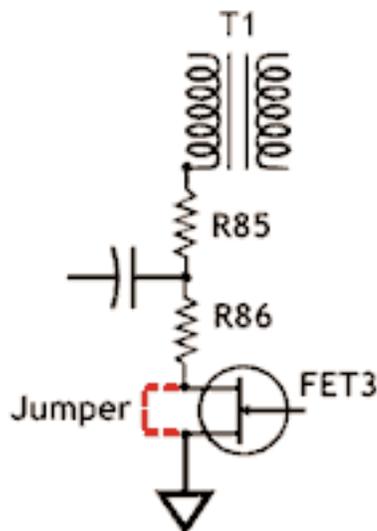
### Poor or No Touch-Tone (DTMF) Decoding

Since touch-tone receive levels vary from area to area, a modification to the VRC2000 flexible circuitry may be needed to accommodate these variations. Gain on the DTMF receive amplifier circuit is a factory setting that may be too high for certain Central Office telephone lines and other types of telephone systems, thus causing the DTMF tone level to distort. The level of the DTMF tone should be reduced into the decoder. A simple modification to the VRC2000's flexible circuitry will accomplish this.

This block diagram is also on Page 227 (Figure 24) in the VRC2000 Installation and Operations Manual. This block diagram is also on Page 84 (Figure 24) in the VRC2000 Installation and Operations Manual (Rev. 2.00). Typical readings of the DTMF level: U16, pin 8 < 1 Vpp when receiving the DTMF tone. If more attenuation is needed even after the modification has been done to FET3, R49 can be changed from a 20kOhm resistor to a 39kOhm resistor.

FET3 needs a jumper put between the source and drain (two outside legs of the FET). This will set up a voltage divider circuit for the incoming DTMF tone and attenuate the signal by 6dB before the signal reaches the amplifier circuit. If the FET is bad, old, or noisy, this can add distortion into the incoming DTMF tone and not allow the decoder to read the signal. The jumper also cleans up the distortion from the noisy or bad FET. (See block diagram, below.)

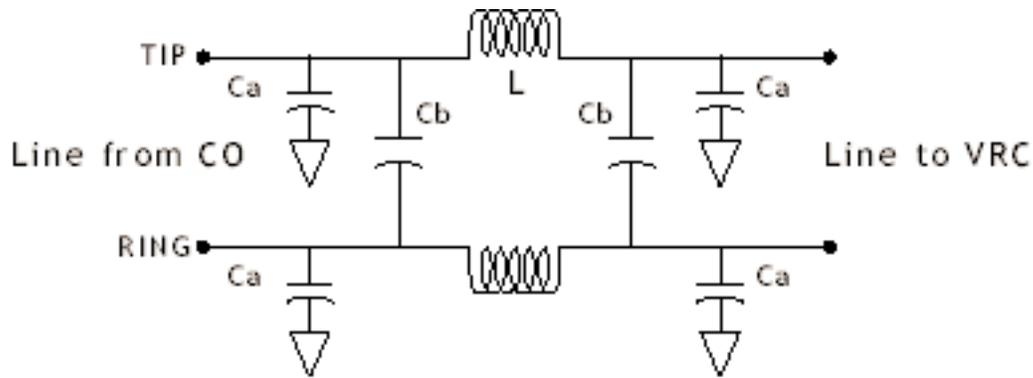
### RFI Interference (Poor or No Touch-Tone Decoding or No Auto-Answer)

RFI interference occasionally affects the VRC2000 by not allowing the unit to auto-answer or by intermittent touch-tone (DTMF) problems.

RFI problems typically are cured with any or all of the following suggestions: Correct site grounding problems. Avoid wiring which creates ground loops (two paths to station ground) Update the phone company's surge protection. AM RFI is often generated by central office carbon shunt surge protectors that are installed from tip-and-ring to ground. Update the carbon shunts to the gas tubes. Build or buy an RF filter for the phone line. Gentner supplies a Telephone Surge Protector with the VRC2000, but does not provide an RF filter for the phone line. This can be bought through your local phone company or a filter can be built up using a diagram of an RFI filter. (See diagram, below.)

L	Ca	Cb
AM	22uH	0.0022uH	1000pF
FM	390-500uH	220pF	100pF

**Note:** AT&T's Z100A filter has performed well at AM sites.
