SERVICE BULLETIN

PRODUCT JH-110 RECORDERBULLETIN NO. 202**SERVICE BULLETIN**DATE APRIL 29, 1976P.C. BD. POWER HARNESS No. _____ECO NO. 162 IN NEW PRODUCTION April 20, 1976

PRODUCT JH-110 RECORDER

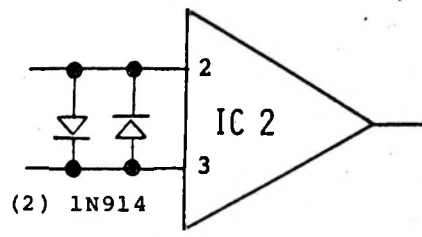
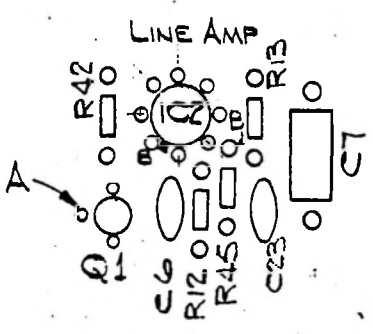
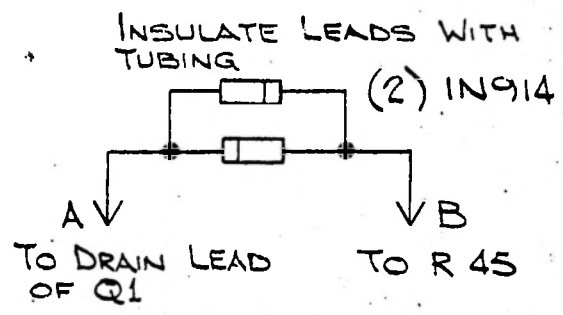
Add two (2) 1N914 diodes from pin #2 to pin #3 of the output op-amp (IC2). Repeat for each Reproduce Bd. (Reverse parallel connection)

To protect the op-amp from static High Voltage failure.

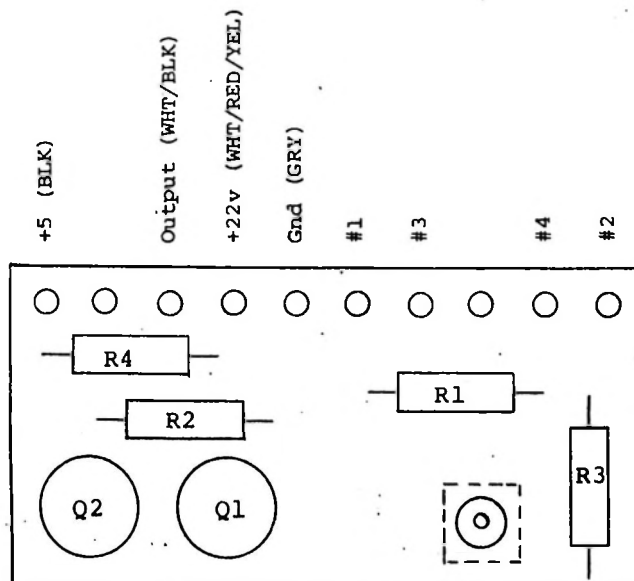
26B160

This amplifier board is a direct replacement for the terminal strip which contains conditioning components for the TAPE BREAK SENSOR. Locate this terminal strip directly under the Tape Break Sensor. It has mounted on it: a capacitor, two resistors, and a zener diode.

1. Unsolder all of the wires going to this terminal strip. Remove the terminal strip. Mount the amplifier board, using the same mounting screw.
2. IF there were TWO BROWN wires going to one of the lugs on the terminal strip, solder these two wires together and insulate the end with tape (*These wires are not to be connected to the new board*).
3. Refer to the drawing below and the Wiring Chart on the back of this page for the correct color code for your machine.

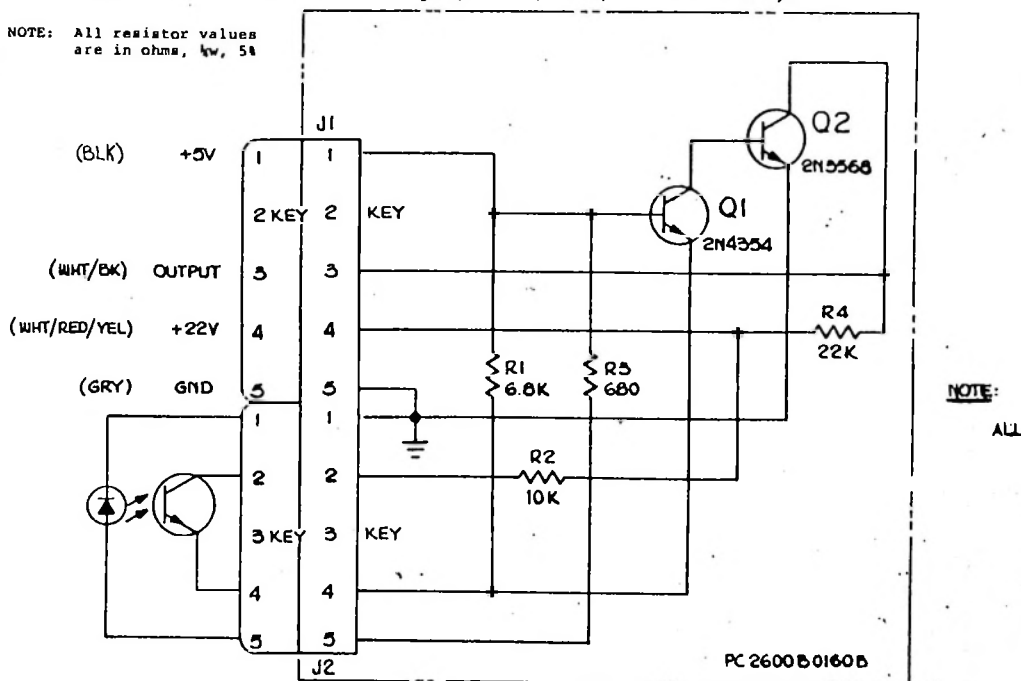
NOTE: R19 on deck Mother Board must be replaced with a Jumper wire to provide +5v.

4. After you have connected all wires to the new amplifier board, there is one change to the Transport Mother board.
 5. Unplug the Phase Locked Loop board.
Locate R19 on the Mother board, near the right end-center position.
 6. Remove R19 and replace with a Jumper wire.
 7. REASSEMBLE. THE MODIFICATION SHOULD NOW BE COMPLETE.
- * Some early JH-100s have no +22volts on the terminal strip. +22volts can be found at the MVC assembly. (White/Red/Yellow wire).

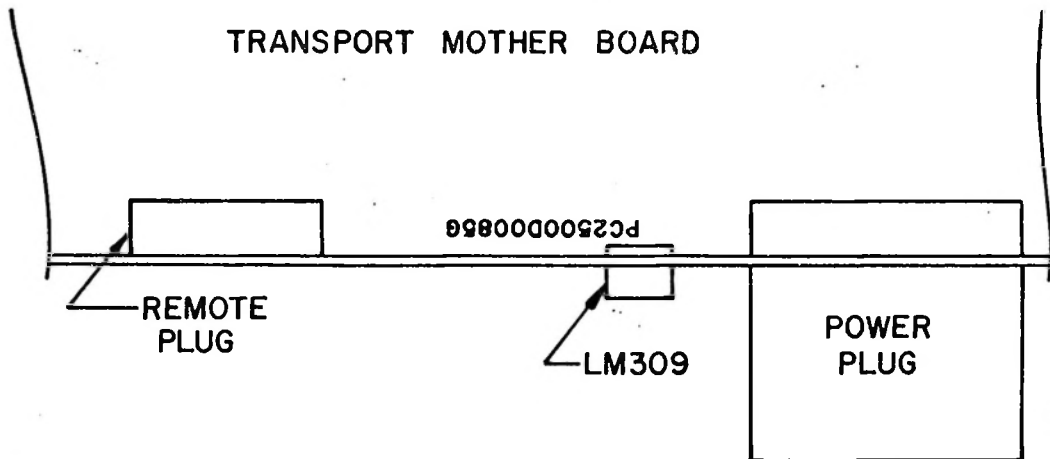
1. The revision level is printed on the bottom of the Transport Mother board in the location shown here:
