**SONY**  
Broadcast

This bulletin identifies recommended tools and alignment fixtures for the BVU Series Broadcast VTRs.

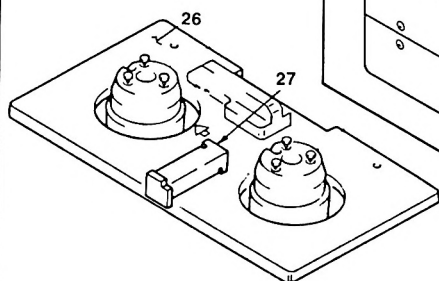
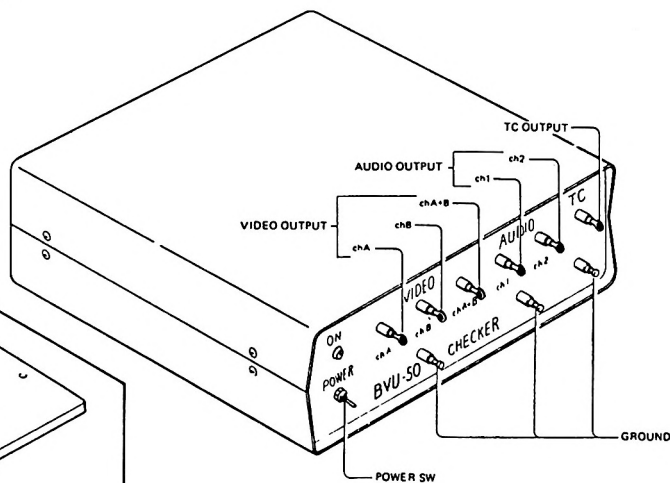
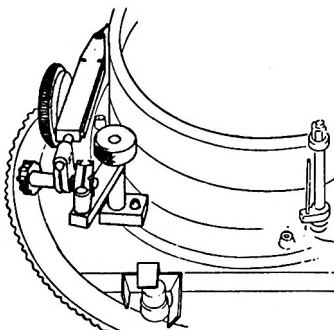
**BUV-50, -110, -200, -200A, -200B**  
Gauges installed (forward mode, power off, no cassette).  
Gauges ①, ②, ③ and ④ used in combination.

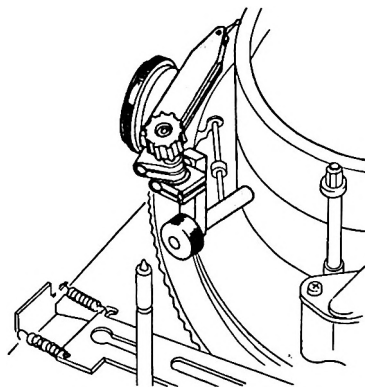
**BVU-100**  
Gauges installed (normal threading mode, power off, no cassette).  
Gauges ①, ② and ③ used in combination.

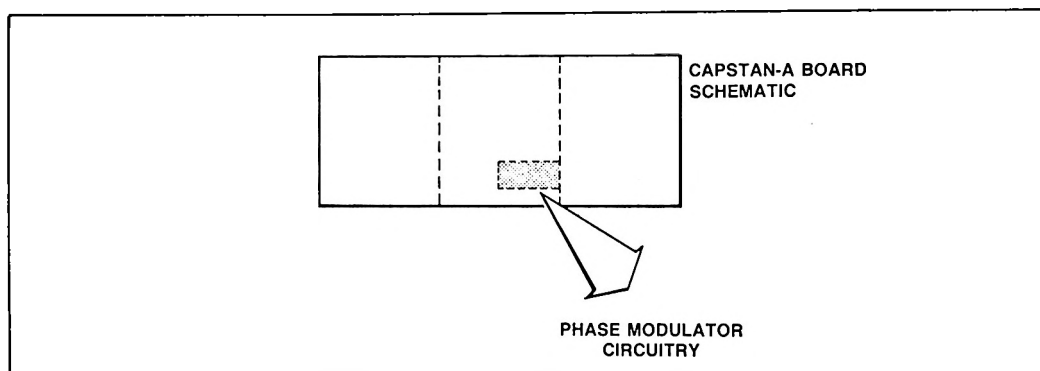
Figure 3

The tape tension may temporarily increase while tracking is adjusted manually. The tension increase is a result of the response characteristics of the Phase Modulator circuits on the CAPSTAN-A Board and TENSION-A Board. The poor response is caused by the inverter chips used in these circuits.

1. Replace IC46 and IC56 with the new chips (See Figures 2 & 3.)

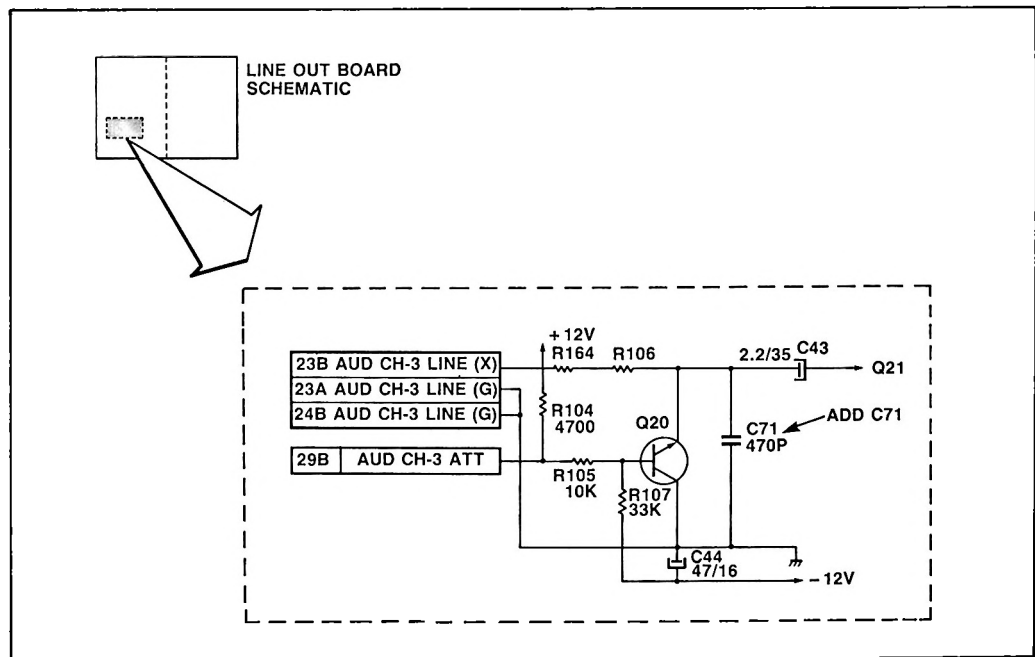
Figure 1

In rack-mounted units, Time Code errors may occur due to noise introduced through the cable harness from the motor or other sources. To resolve this problem, additional filtering on the Line Out Board is recommended as shown in Figures 1 and 2. This modification is applicable to serial numbers 21,100 and lower.

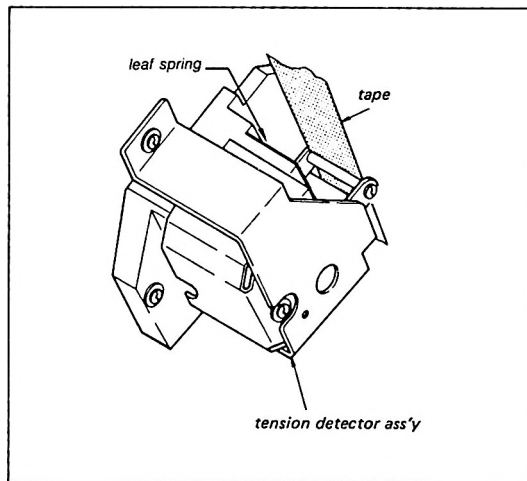
Fig. 4-7. Tension Detector

1. Remove the tension cover and observe whether or not the leaf spring in the tension detector is deformed. If the leaf spring is deformed, replace the tension detector with a new tension detector assembly, and proceed with the following procedure.
2. If the leaf spring is not deformed perform the following procedure:

- d. Short-circuit TP3 and TP4 on the TENSION-A Board.
- e. Measure the voltage (V1) at 13B on the TENSION-A Board with a digital voltmeter.
- f. Remove the short between TP3 and TP4.
- g. Confirm that the voltage at 13B-TENSION-A is V1  $-4.0 \pm 0.3V$ . If this specification is not met, proceed to the adjustment in Sec. 7-3.
- h. Remove the short between TP1 and TP2.

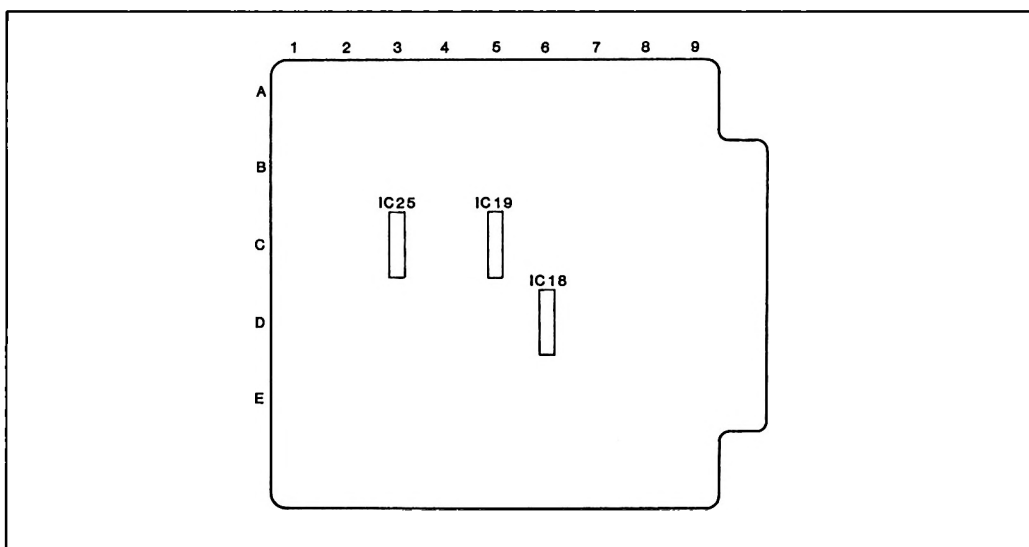
Figure 1. Framing-A Board (Component Side)

This modification corrects reliability problems associated with IC Type MM74C74N on the Framing-A Board. The recommended replacement for this part is IC Type TC40H074P. The modification has been implemented in units with serial numbers 20,501 and higher. In earlier units exhibiting reliability problems, replace IC18, IC19 and IC25 on the Framing-A Board with the new part listed below:

| Part | Old Part No. | New Part No. |
|---|---|---|
| IC's 18, 19, 25<br>(Figure 1) | MM74C74N<br>8-759-994-74 | TC40H074P<br>8-759-220-74 |

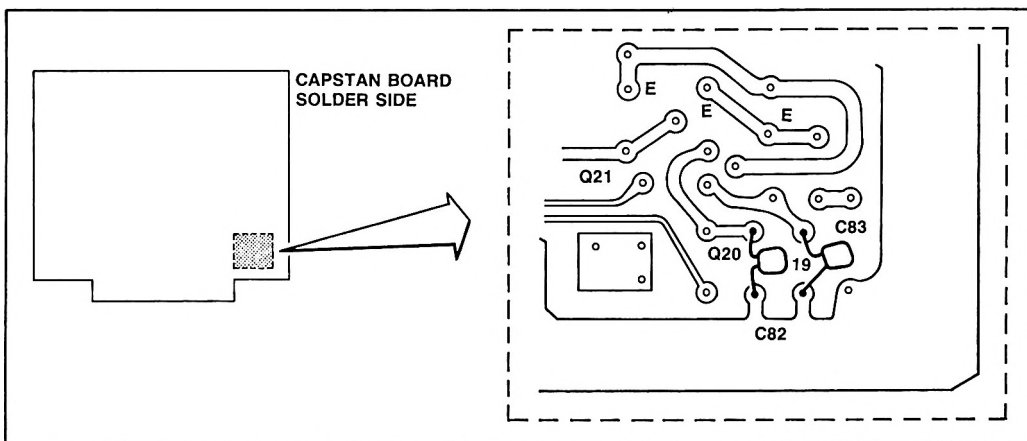
**Figure 1**

Noise may be generated in the Capstan FG, causing the Capstan error voltage to vary; this may cause the Capstan and reels to oscillate. The addition of two capacitors to the Capstan Board (Figure 1) will correct this problem.

Between base and GND of Q19 . . . C83

Between base and GND of Q20 . . . C82

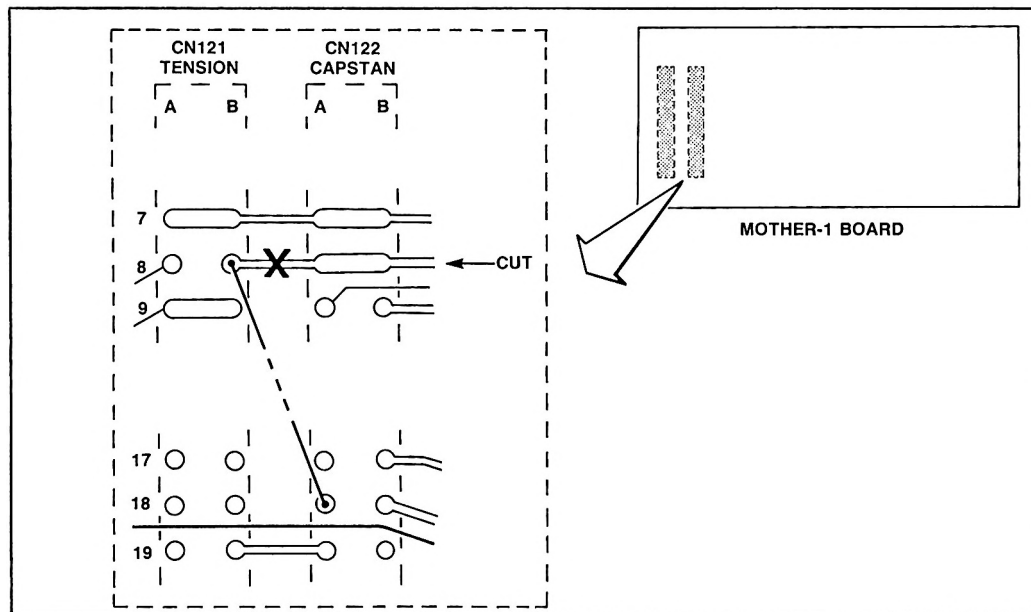
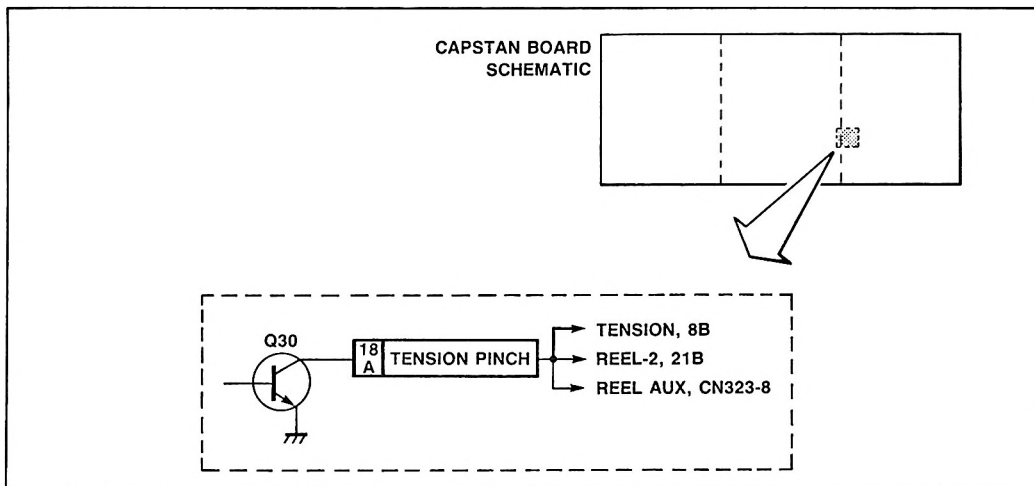
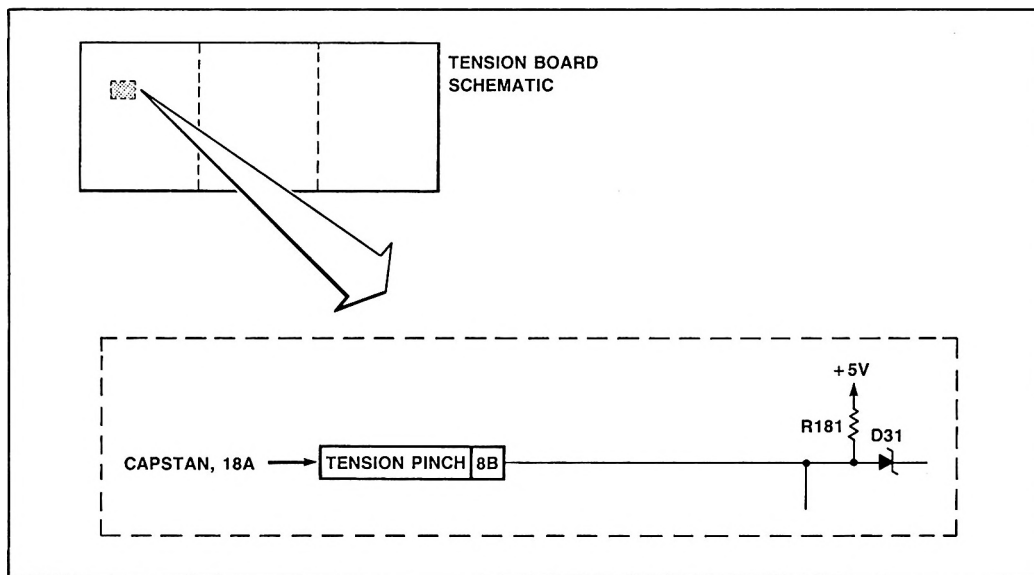
**Figure 1**

When changing from P. JOG X2 to PLAY, the tape tension around the head drum may be reduced momentarily. This is caused by a change in the response characteristic of the Tension Detect circuit which supplies feedback to the reel servo. The problem can be eliminated by changing the control signal to the Tension Detect circuit from NOR FWD to TENSION PINCH.

1. Cut the trace between CN121-8B and CN122-8A.
2. Jumper CN121-8B to CN122-18A.

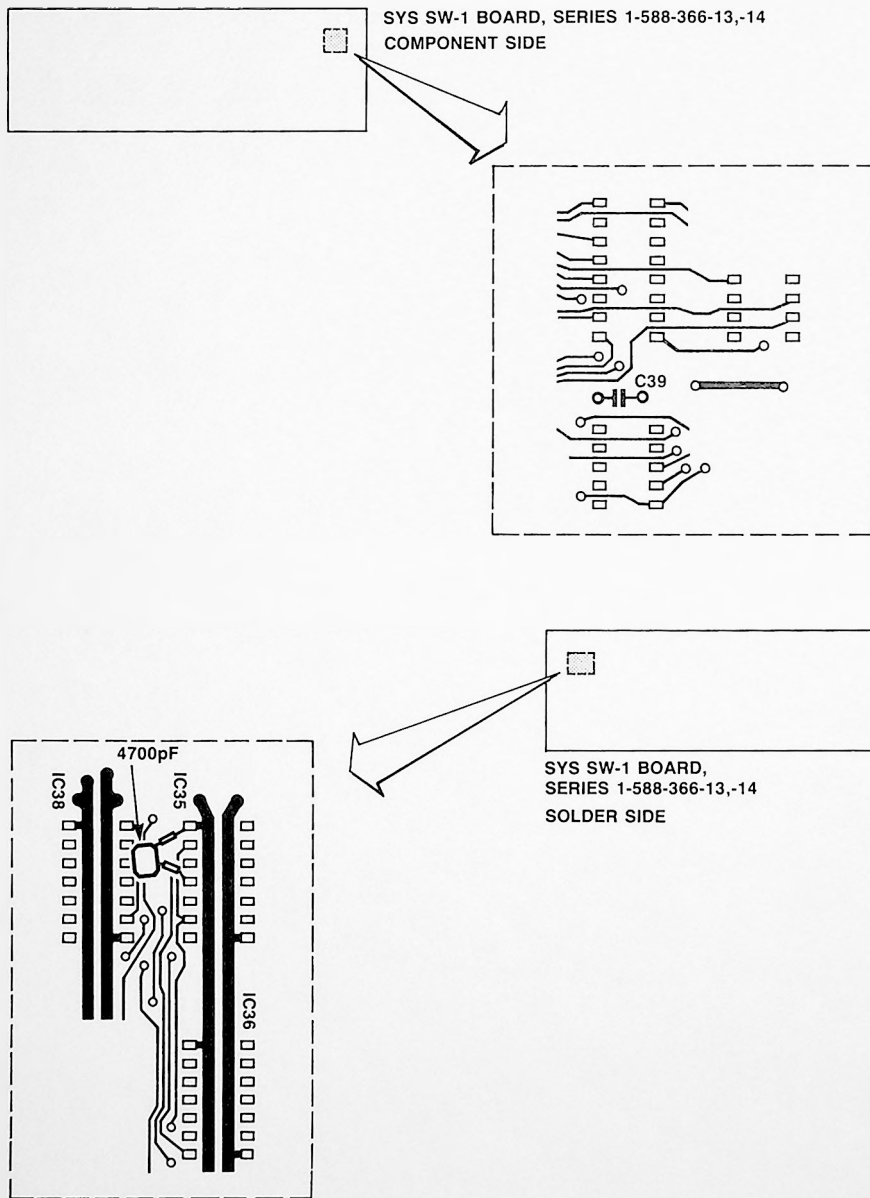
Figure 1

Capacitor C39 was added to the JOG button circuit to guard against static charges. However, the ground path provided by the foil has proved to be inadequate. The problem can be overcome by repositioning C39.

1. Remove C39 from its present position. (See Figure 1.)
2. Install 4700pF capacitor between IC35-4 and IC35-7.

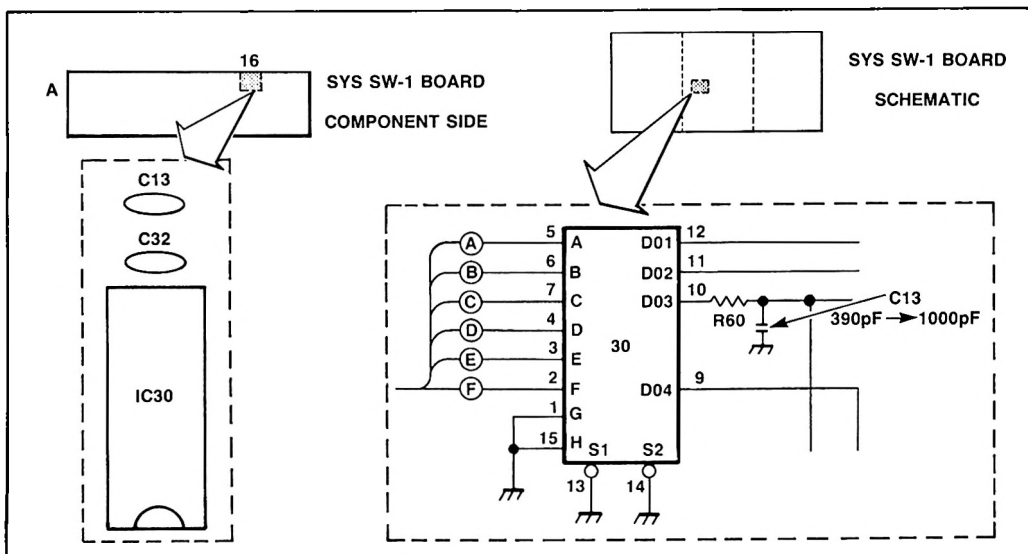
**Figure 1**

When power is applied the Play lamp may turn on but the VTR will remain in Stop mode and reject commands. This problem is caused by transients which introduce a false Index Pulse into the clock. The faulty clock effectively shifts the data, and commands will not be accepted by the system control circuits.

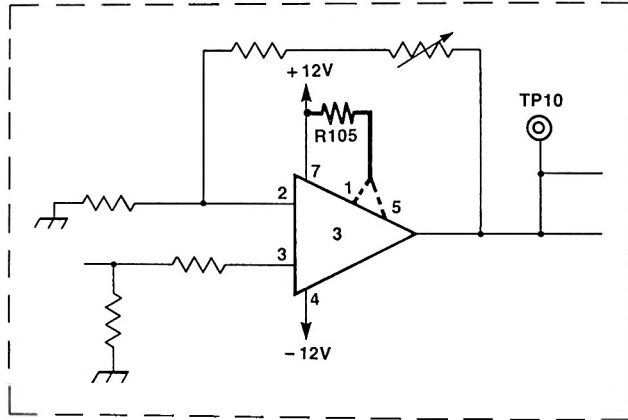
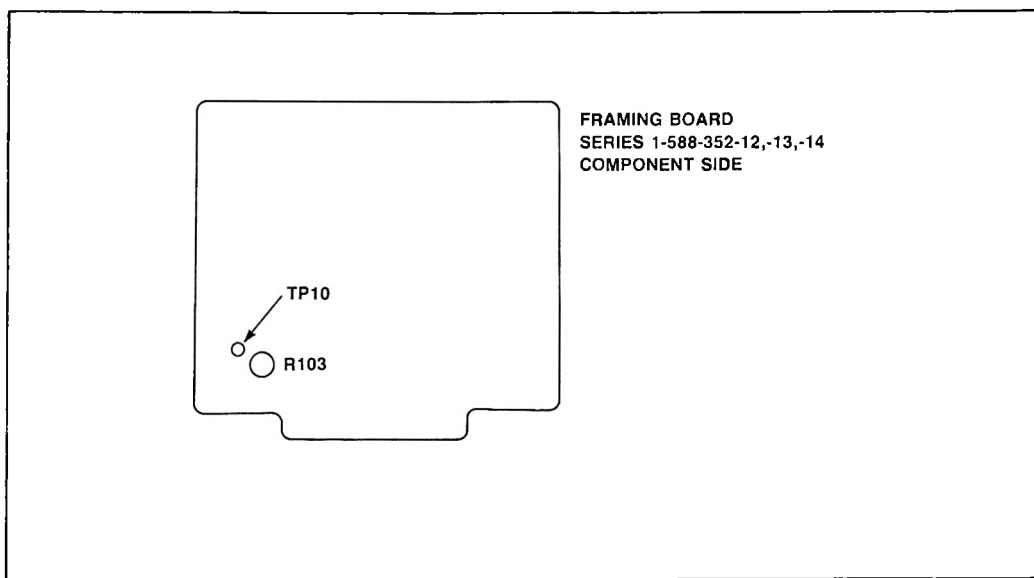
Figure 1

The DC offset of IC1 on the Capstan Board and IC3 on the Framing Board must be checked if they are replaced. Excessive DC offset will distort the playback CTL, causing errors in the framing circuitry.

1. Place VTR in EE mode and measure DC offset at TP10 on Framing Board. Specification is  $0.0 \pm 0.1$  VDC.
2. If DC offset is not within specification, adjust R103.

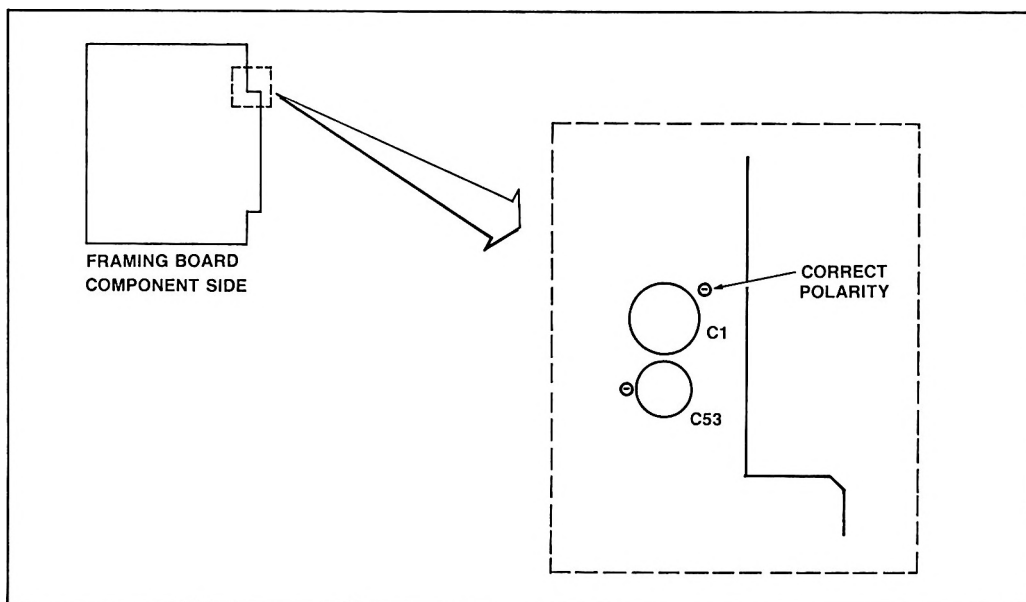
Figure 1

Capacitor C1 on the Framing Board may be mounted with its polarity reversed. The capacitor must be replaced on boards where this has occurred. (See Figure 1.)

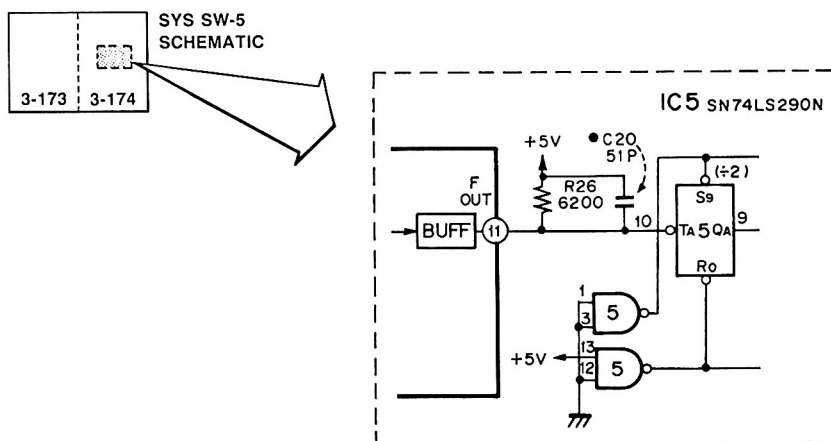
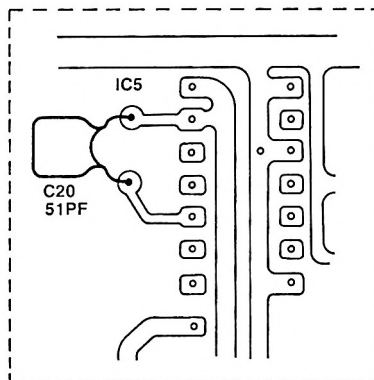
Figure 1

Tape speed in the Programmed Jog mode may actually be twice as fast as the speed indicated on the SEARCH dial. The problem is caused by noise generated on the trailing edge of the V-F Converter Output (IC8) on the SYS SW-5 Board. This noise may be recognized as a valid count by the next counter stage, IC5. As a result, the Programmed Jog Speed Out frequency will be doubled. Installation of filter capacitor C20 as shown in Figures 1 and 2 will eliminate this problem.

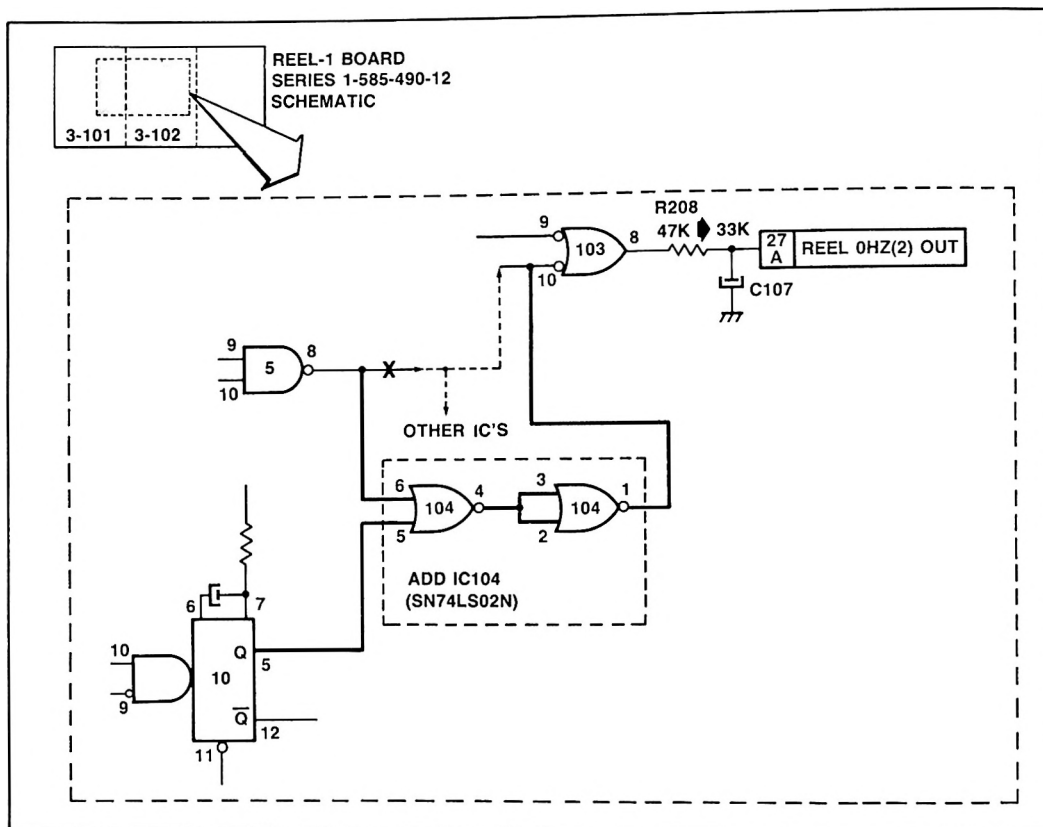
Figure 1

The Reel-1 Board generates a "Reel 0Hz (2)" signal when the VTR is stopped, and clears this signal when the machine enters PLAY. The Reel 0Hz (2) circuit contains an RC circuit which must have its capacitor discharged when entering PLAY. Rapid shifts between STOP and PLAY can prevent this from happening, and ultimately cause tape to slacken around the head drum.

1. Replace R208 with 33k ohm carbon resistor. (See Figure 2.)
2. Add new IC104 to unused area designated IC12. (See Figure 2.)

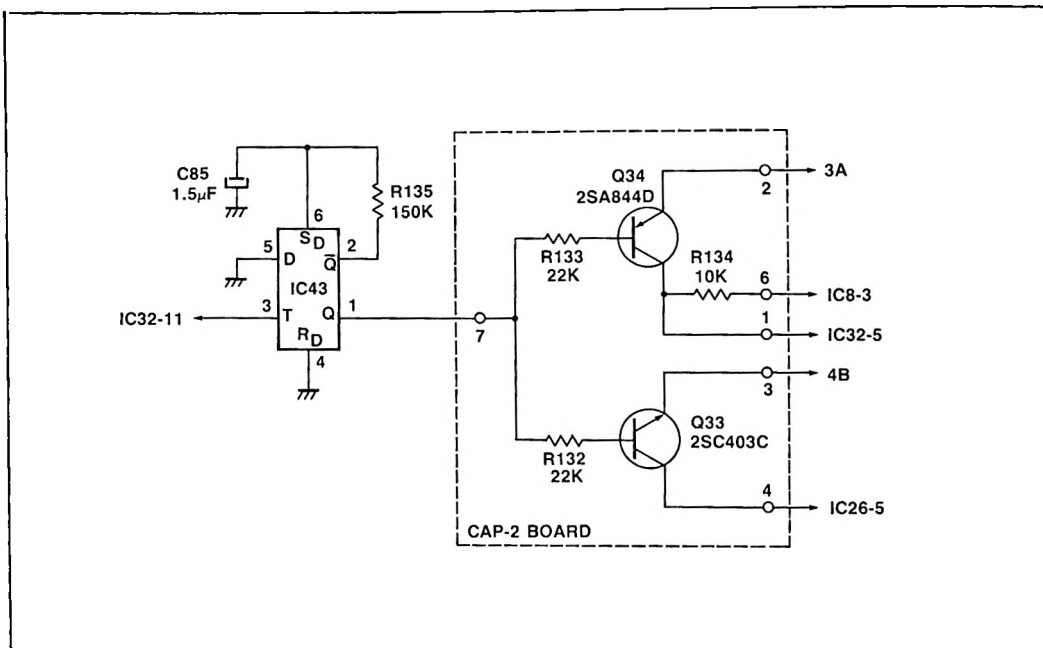
Figure 1

In a BVH-1100 equipped with the DT option, there is a momentary loss of tape tension around the Head Drum when the machine is set into PROGRAM JOG  $\frac{1}{5}$  from PLAY. The resulting loss of head-to-tape contact causes a distortion or break-up in the output video signal.

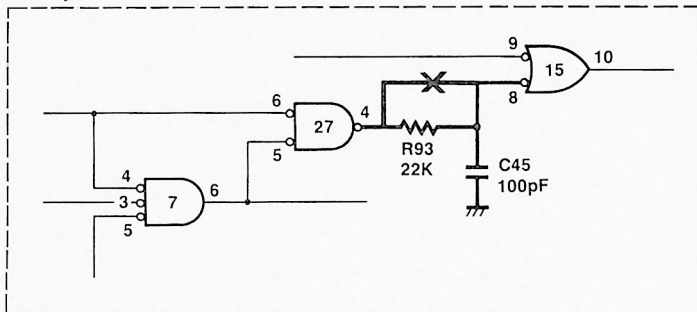
Figure 2

This modification is applicable to serial numbers 10,600 and lower. During the REVIEW mode the output from Audio-3 may be muted for 8ms at either the "In" point or the "Out" point of the edit. This occurs because of a spurious pulse at IC27-4 which is caused by the propagation delay of IC7 (See Figure 1.) The effect of this pulse can be eliminated with the following modification. (See Figure 2.)

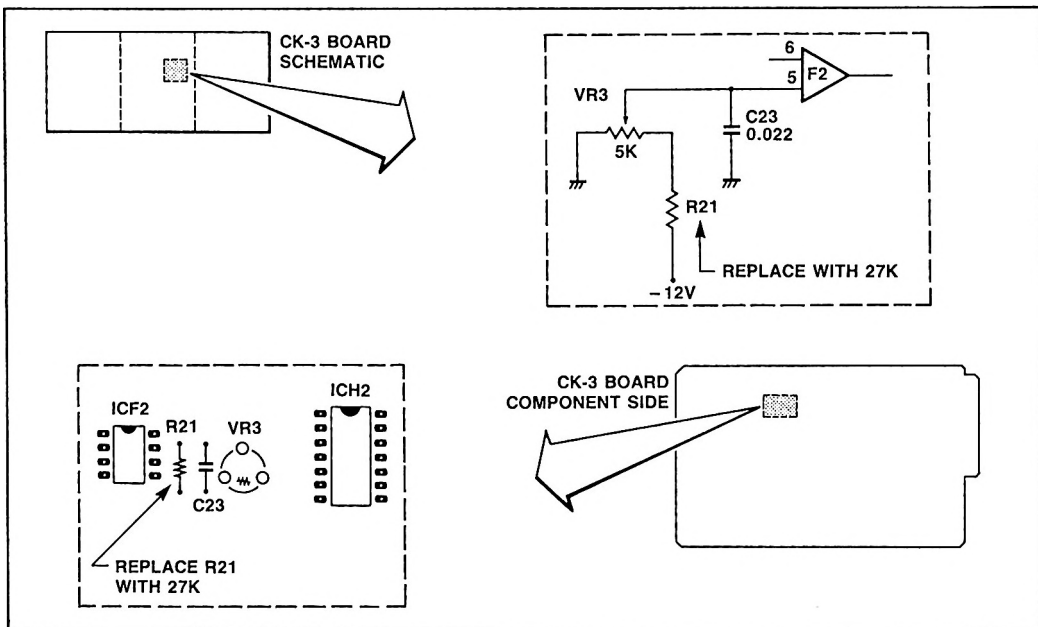
Figure 1

The high sensitivity of VR3 on the CK-3 Board may cause a malfunction of the FAST FWD/REV BIDIREX DETECTOR. Replace R21 (7.5K) with a 27K resistor to correct the problem. (See Figure 1.)

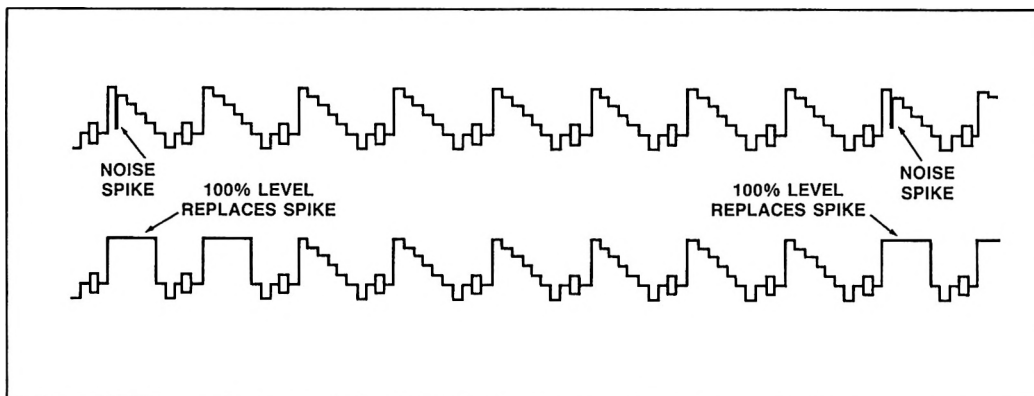
Figure 2

SYMPTOM: Noise on monitor due to defective MY Board.

1. Set up: Connect WFM monitor to TBC output.  
Connect monitor to TBC output.  
Input to TBC — Unmodulated Linearity Signal.
2. Remove MY Boards 8-1 and 8-2 sequentially. Noise will dissappear when defective board is removed.
3. Place defective MY Board on Extender. Observing WFM, switch S1 positions ON/OFF sequentially to determine which Line Block contains the defective IC.  
Ex. When S1-3 is OFF, noise spike disappears and 100% level bar appears. Indicates defective IC is in Line Block 3. (See Figure 2.)
4. Return all S1 positions to ON.
5. Observing waveform, switch S2 positions ON/OFF sequentially to determine which Bit contains the defective IC.  
Ex. The waveform switches from noise to 100% level when position 2 is ON. Then defective IC is in 2nd Bit of Line Block 3. In this case, ICF5 or ICG5 is defective.

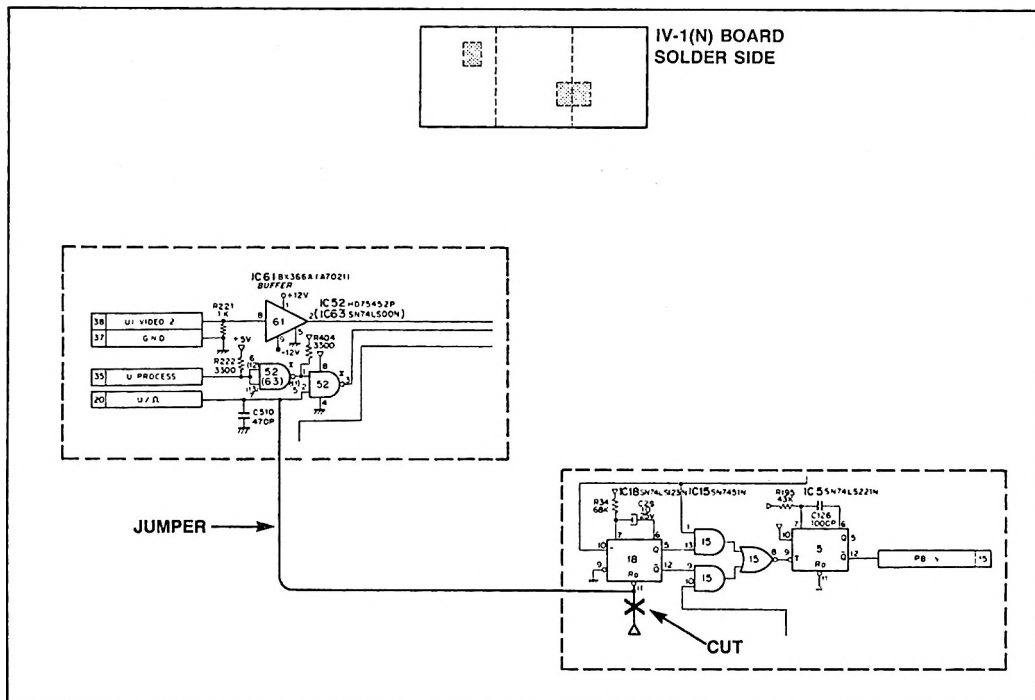
**Figure 1**

The modification shown in Figure 1 will cause the TBC to use the "1st EQ Pulse Detector" whenever a 1" VTR is used for playback.

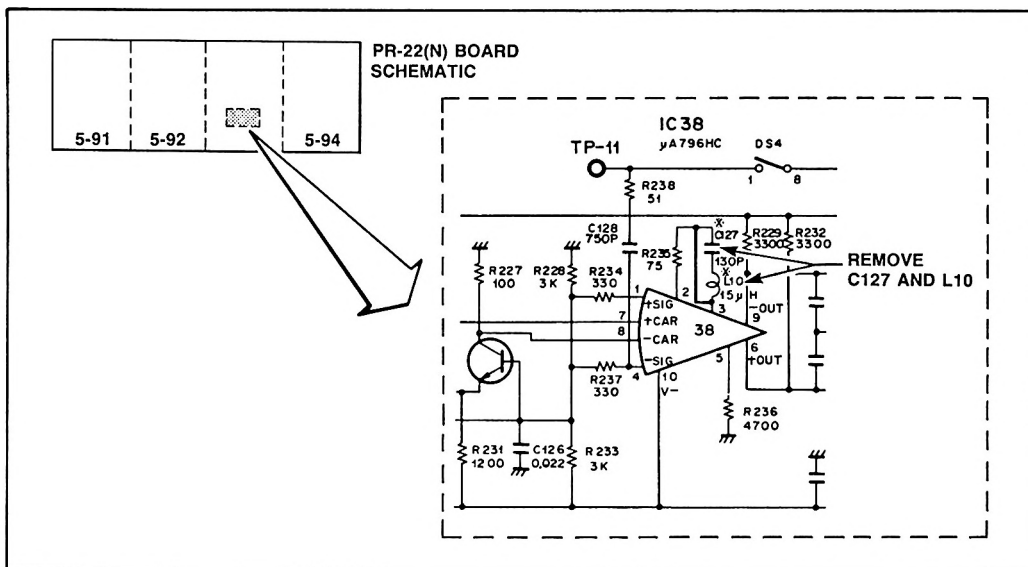
**Figure 1**

Beginning with serial number 10,601, two components were removed from the PR-22 Board to reduce hue deviation caused by temperature changes. Although not in the temperature compensation loops, these components caused temperature changes within the range of 20-25°C. Removing these components in earlier units (S.N. 10,600 and lower) will keep temperature drift within 5-7°C.

1. Remove C127 and L10 from PR-22 Board. (See Figures 1 and 2.)
2. Move R235 to new location: from IC38-2 to IC38-3.

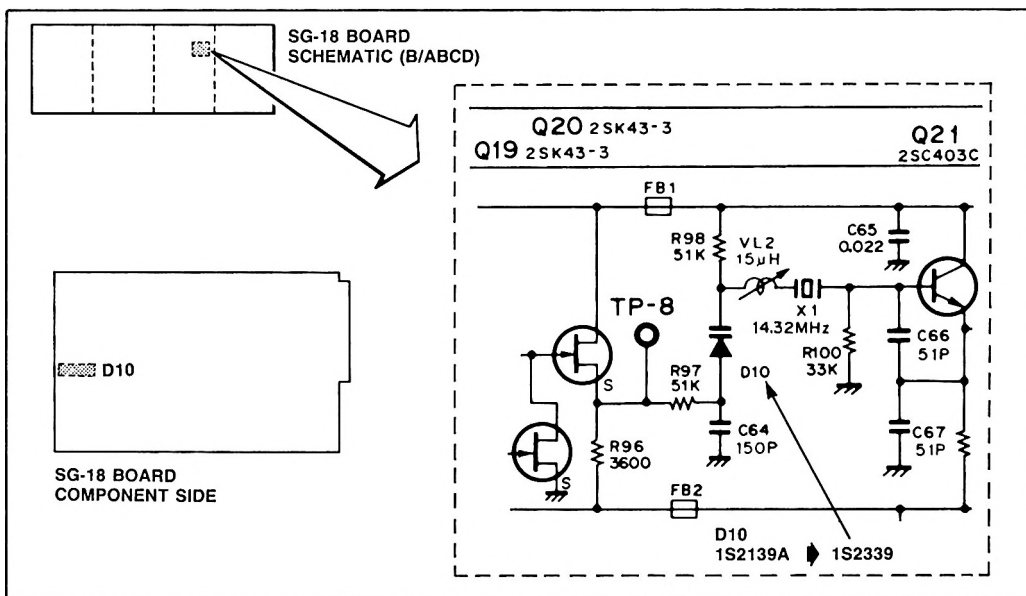
Figure 1

Due to inconsistencies in diode characteristics, the subcarrier phase lock loop may become unlocked at low temperatures. If this is observed, replace D10 on the SG-18 Board with the new diode listed below. (See Figure 1.)

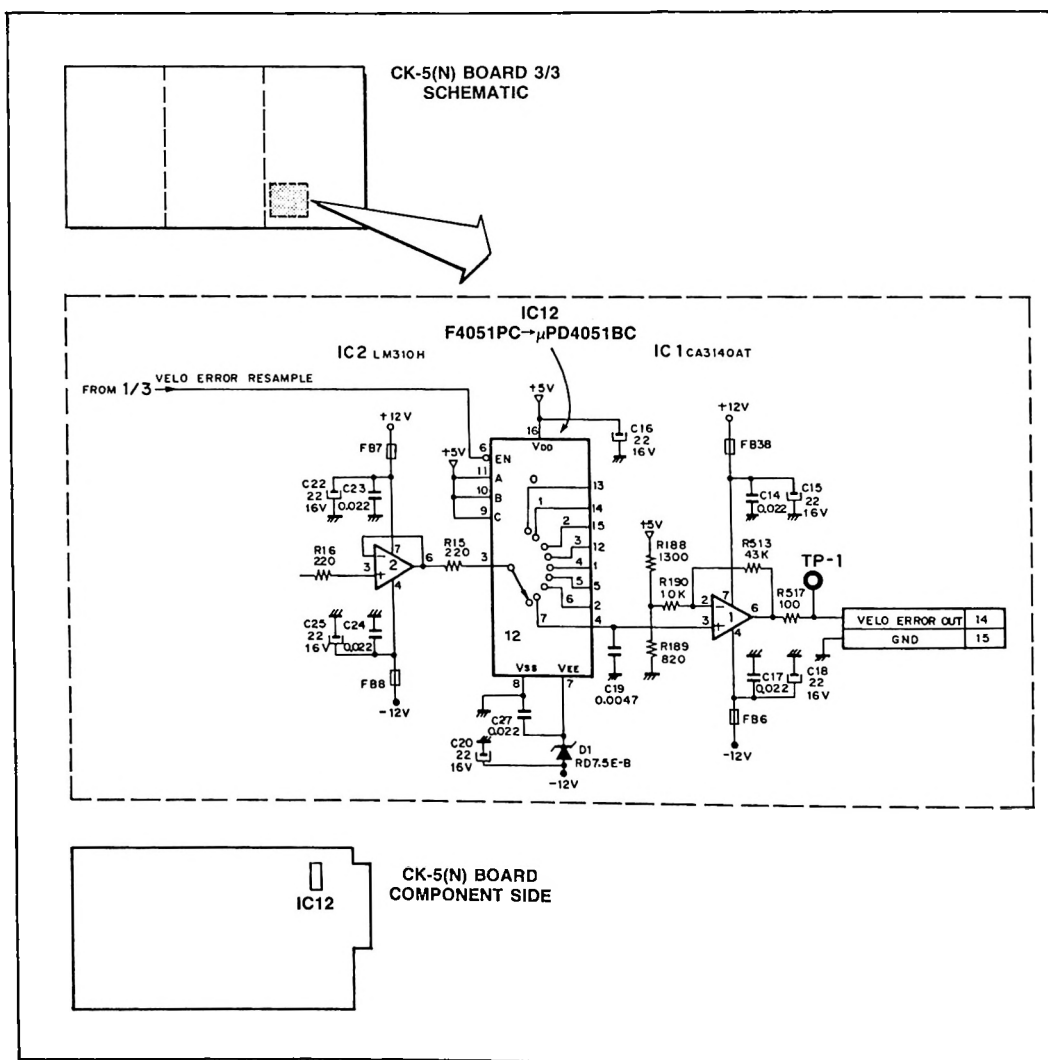
Figure 1

The hue of the video during dropout can vary as much as 10%. This variation is due to differences in the characteristics of the ICs used. Dropout hue variation can be prevented by modifying two boards in the BVT-2000. On the CK-5 Board, IC12 (F4051BPE) is replaced with an NEC manufactured IC ( $\mu$ PD4051BC). On the SG-28(N) Board, a resistor network with an adjustment for the dropout pulse is added.

1. On CK-5 Board, replace IC12 (Fairchild IC F4051BPE) with new IC  $\mu$ PD4051BC. (See Figure 1.)
2. On solder side of SG-28(N) Board, install the following parts as shown in Figures 2 and 3. Use insulated wire for long jumpers.

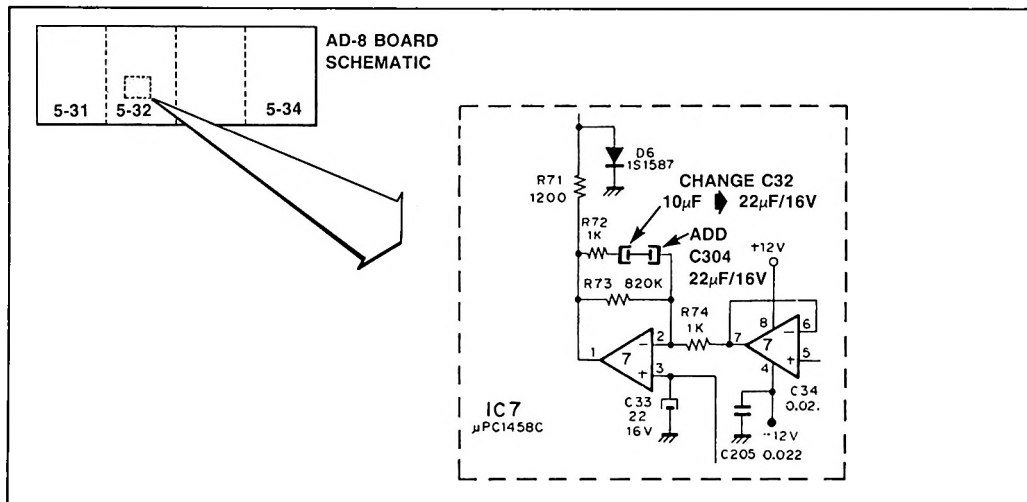
The set-up level is increased approximately 40 IRE in some BVT-2000 Digital Time Base Correctors. This is due to transients during on/off switching that can damage C32 on the AD-8 Board. The damage will result in increasing leakage and changes in set up level. If this is observed, apply the following modification.

Replace C32 on the AD-8 Board with two new capacitors, 22 $\mu$ F/16V. The reference designation for the additional capacitor is C304. This changes C32 into a non-polarity capacitor and prevents capacitor leakage caused by inverse voltage. The Parts Required table lists the part number for the new capacitors. Figure 1 shows the change to the schematic. Figure 2 shows the modification applied to the AD-8 Board.

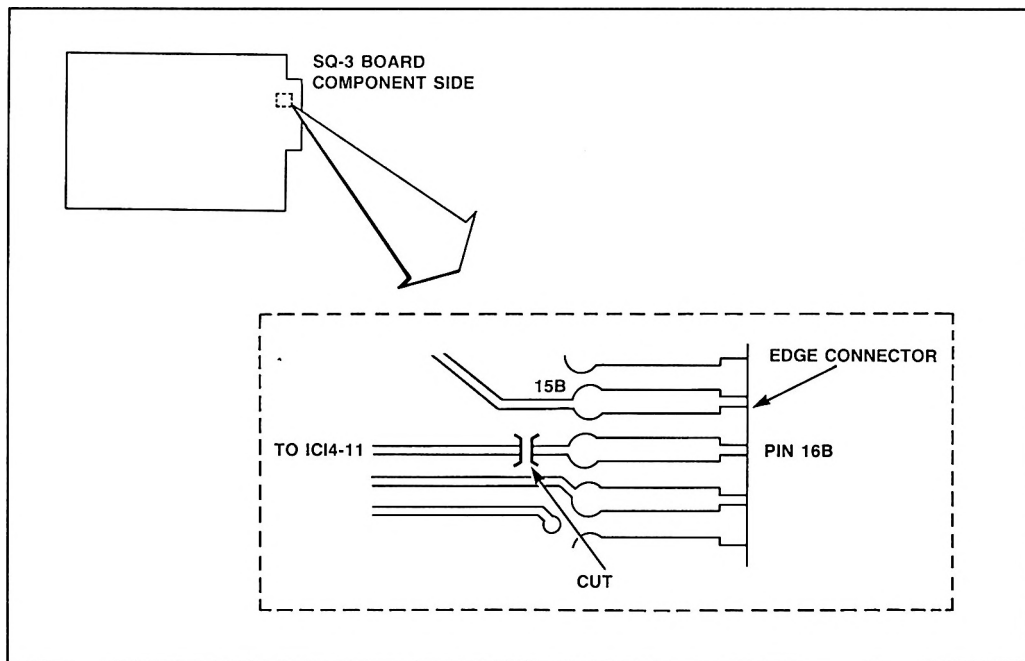
Apply the following modification to the SQ-3 Board to prevent video phase shift during CNR ON/OFF. The modification removes an unnecessary signal from the circuit. Figure 1 shows the modification applied to the component side of the SQ-3 Board. The schematic is unchanged.

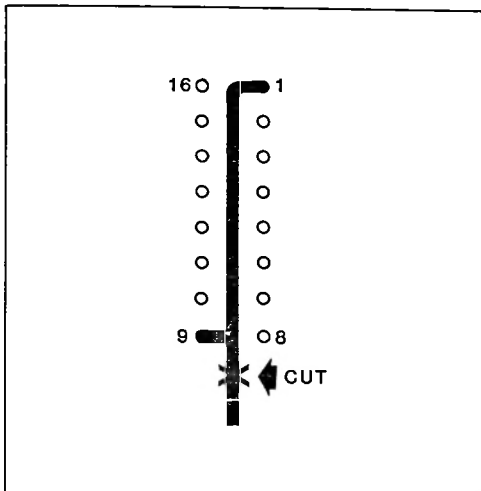
**Figure 2. Location M4 (Foil Side)**

This modification provides improvements in the BVT-2000 horizontal sync circuits. The modification is designed to prevent inadvertent detection of half-H as the horizontal sync, which would result in a 140ns displacement of the picture. This picture shift is most likely to be observed in the DT mode. The modification may be applied to all units in which the horizontal shift symptom appears.

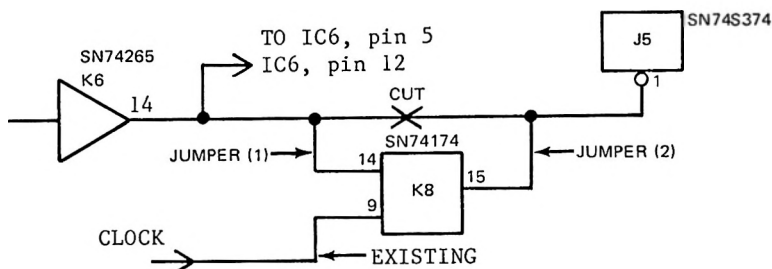
Synchronize the ID BLOCK with the clock.

Make a pattern cut as shown (foil side).

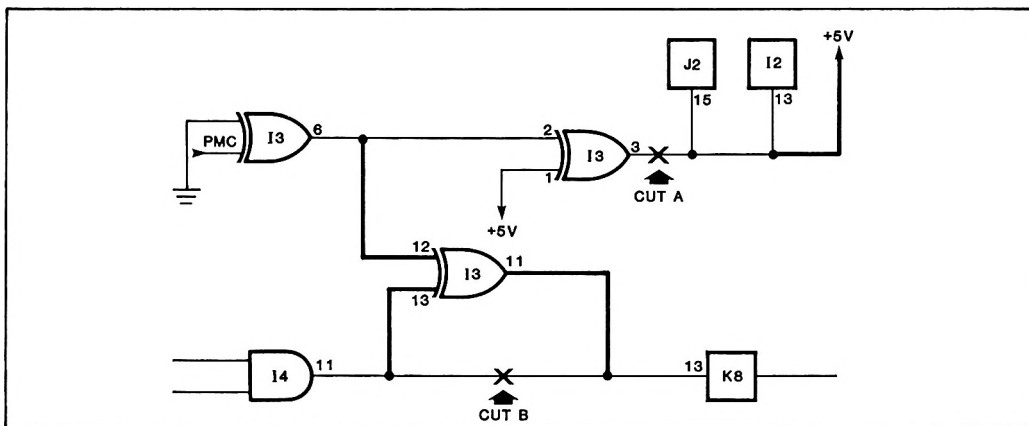
Figure 1

When the DOC switch in the BVT-2000 is ON, occasional black streaks may be noticed in the picture when dropouts occur. This is due to a slight decrease in Y level, caused by inversion of the chroma signal. (The previous line of chroma is inverted and used to replace the dropout.)

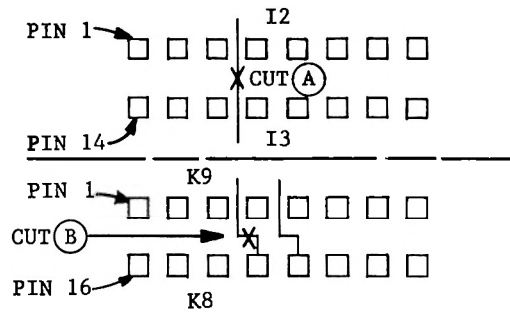
When the DOC switch in the BVT-2000 is ON, occasional black streaks may be noticed in the picture, whenever a dropout occurs. This is due to a slight decrease in Y level, caused by inversion of the chroma signal. (The previous line of chroma is inverted and used to replace the dropout.)

2. Cut the foil as shown (component side).

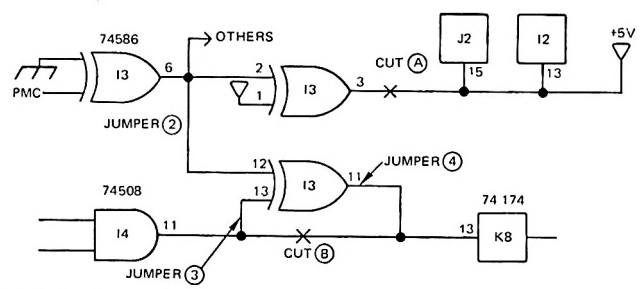
## Pattern Cuts

During compensation for dropouts, the chroma is inverted. (More precisely, the previous H Chroma line is inverted and used to replace the dropout signal.) This inversion results in a slight decrease in the Y level.

Offset the Y level by applying the PMC signal (chroma inverting signal) during dropout reinsertion.

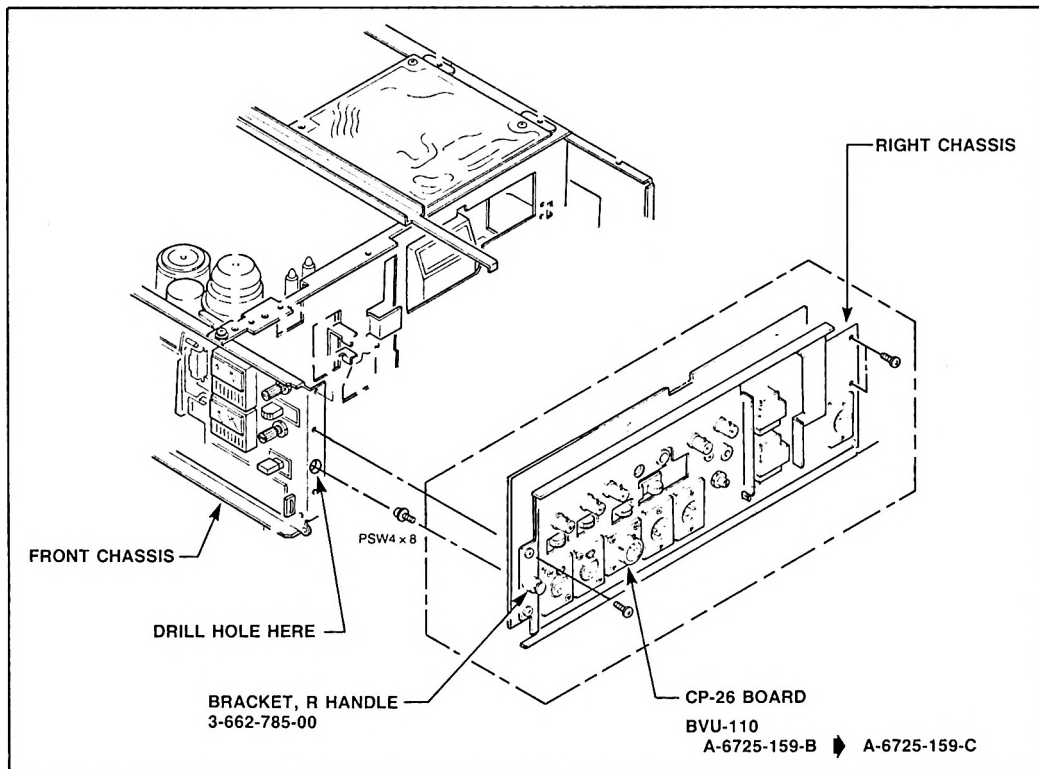
Figure 1

The CP-26 Board, R Handle Bracket and the method for attaching the bracket have been changed in units with S.N. 20,651 and higher. (See Figure 1.) Installation of the new board in units with S.N. preceding 20,651 will require drilling a hole in the Front Chassis as illustrated below. Table 1 indicates the interchangeability of former and new parts.

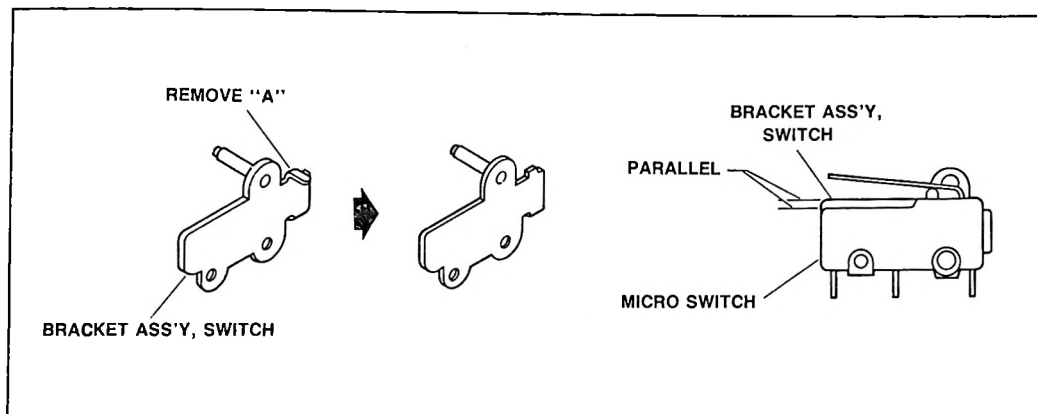
Figure 2

In models with serial numbers listed below, micro switches S1 through S7 have been replaced to improve reliability. Consequently, the switch bracket assembly has also been changed. See Table 1 for former and new part numbers. Table 2 indicates the applicability of former and new parts.

1. Replace former switch bracket assembly with new part as shown in Figure 1, then install new switches to new assembly. Or . . .
2. Modify former switch bracket assembly by cutting off section "A," then install new switches parallel to former assembly as shown in Figure 2.

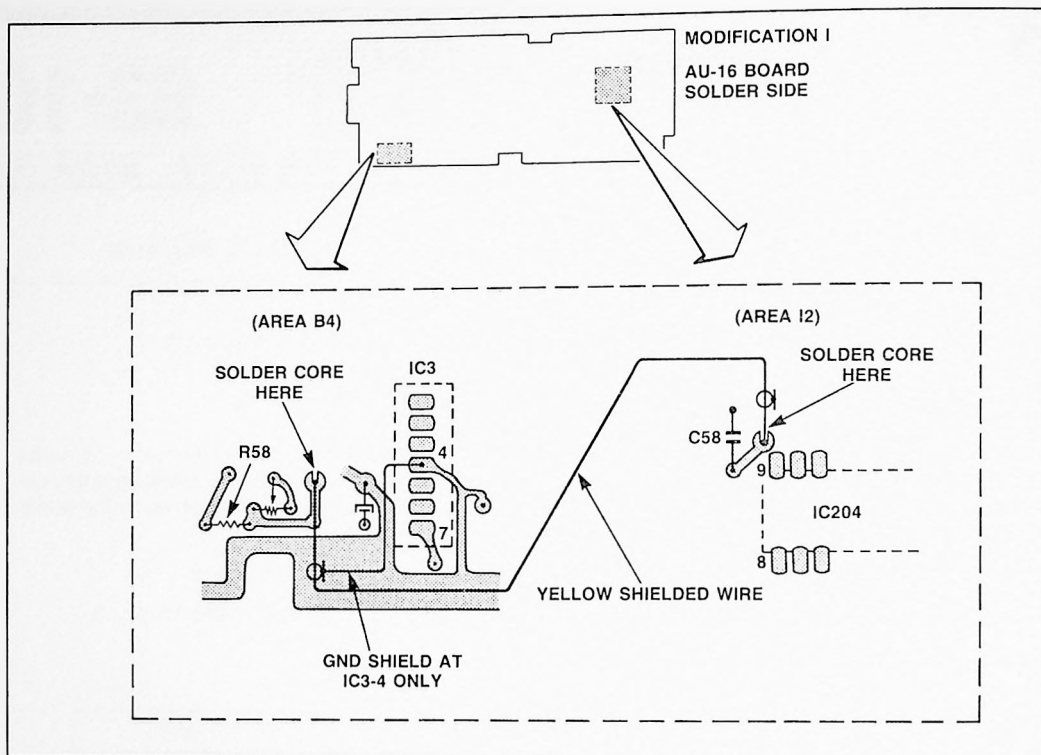
Figure 1

When the BVU-110 is used in a strong electromagnetic environment, interference may appear in the Audio Line Out. Although this problem is audible only in areas of 120dB $\mu$ V/m or higher, the following modifications are recommended if either or both of the crosstalk problems described below appear in the audio output:

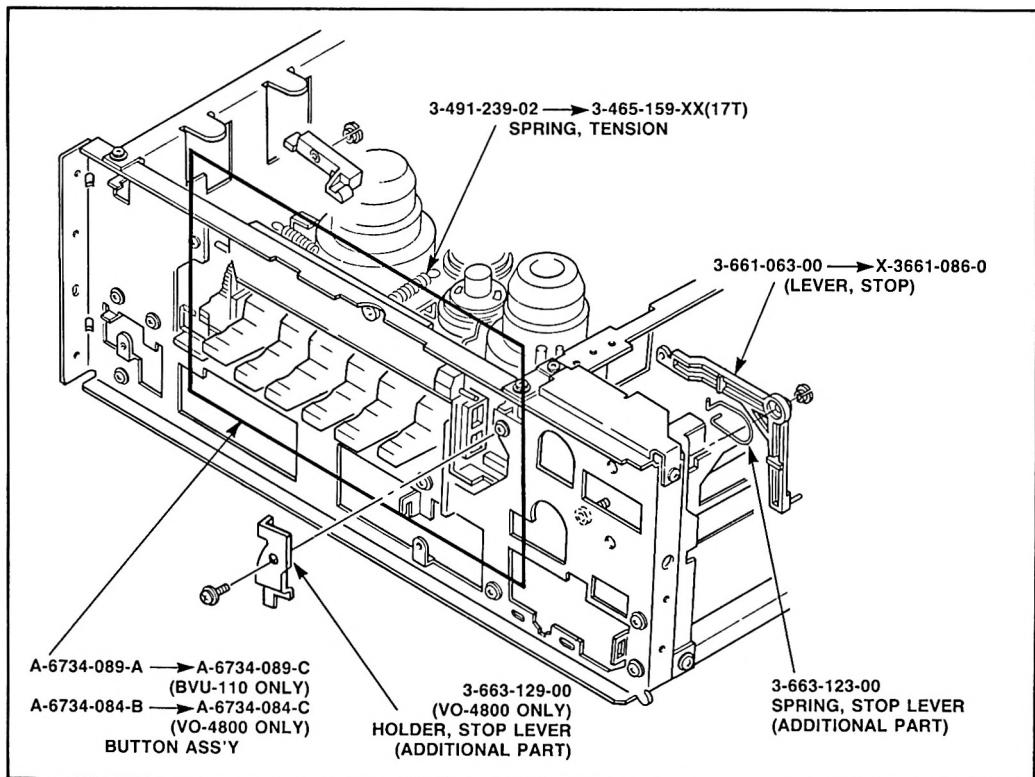
Figure 1

The Stop Lever material has been changed from plastic to zinc for a more effective transfer of power to the Stop Solenoid. In addition, the Stop Lever Spring has been added and the Tension Spring of the Button Assembly has been changed. (See Figure 1.)
