**SONY**  
Broadcast

This bulletin identifies recommended tools and alignment fixtures for the BVU Series Broadcast VTRs.

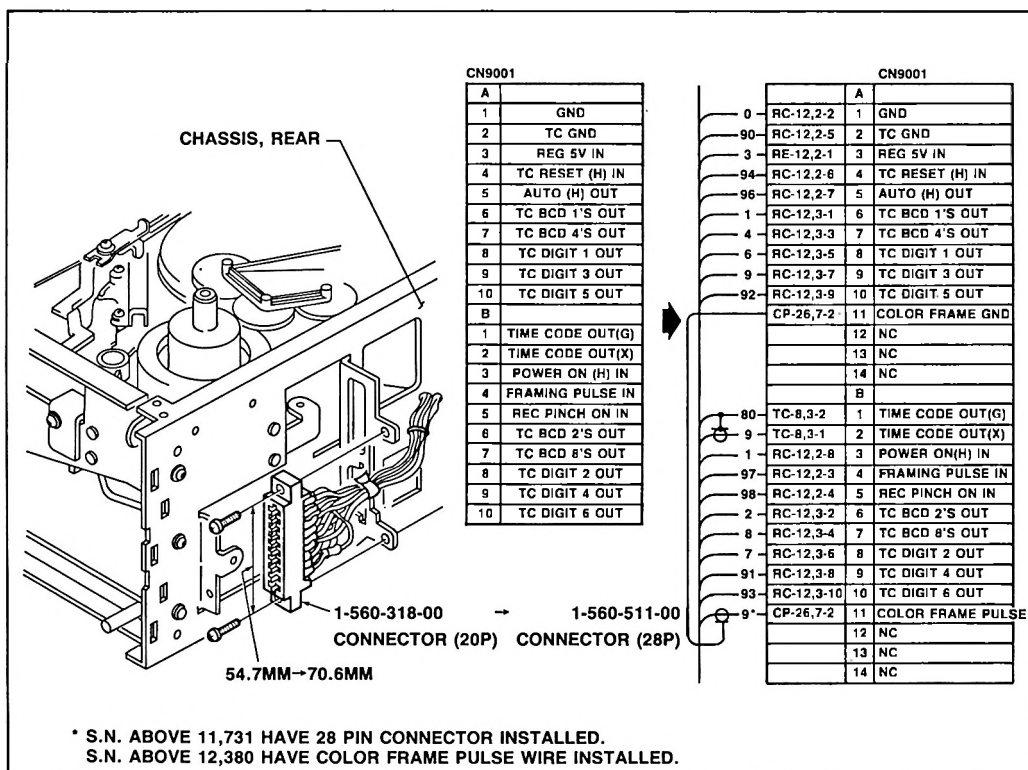
Figure 1

The 20P connector (1-560-318-00) for the BK-111 TIME CODE on the BVU-110 has been changed to 28P connector (1-560-511-00) to make it compatible with other BVU-110 series. (See Figure 1.) To update earlier machines, the following items listed in Table 1 are required. The BK-111 or BK-112 can then be used in both early and later units.

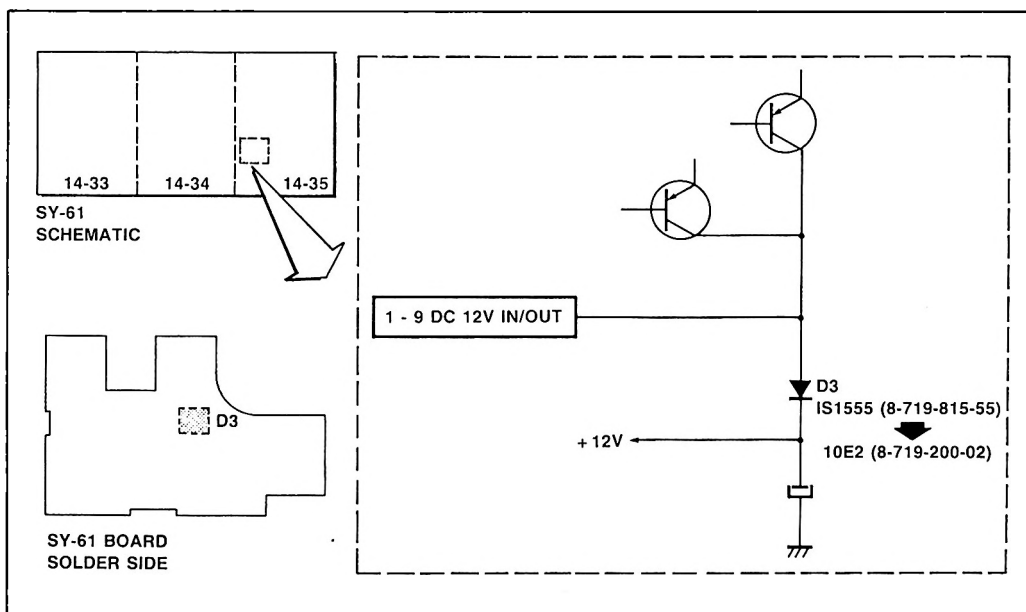
Figure 1

Diode D3 on the SY-61 Board is subject to surge damage when power is applied to the BVU-110. Symptoms of diode failure are as follows:

- Pinch-on does not occur or takes longer than normal following the "Cassette-In-Threading" mode.
- Pinch-on occurs prematurely during transition from STOP to FW. (Tape does not advance for 2 - 3 seconds.)

The problem can be corrected by changing D3 to a 10E2 as shown in Figure 1.

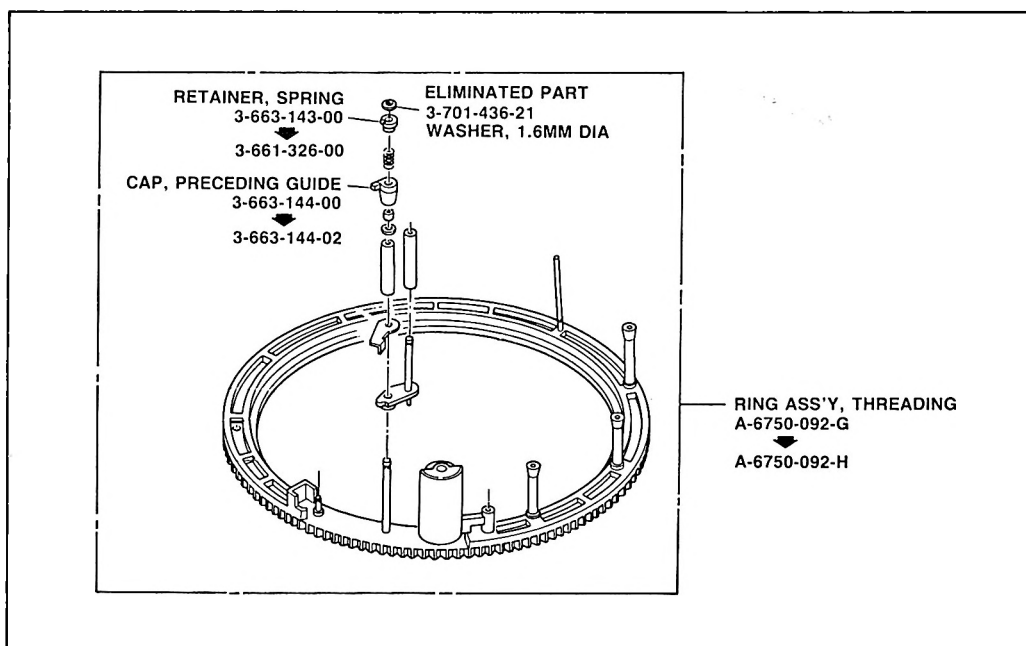
Figure 1

For production reasons the Preceding Guide Cap, 3-663-144-00, and Spring Retainer, 3-663-143-00, have been changed. (See Figure 1.) The 1.6mm diameter washer formerly used in the Threading Ring Assembly, A-6750-092-G, has been eliminated from the new Threading Ring Assembly, A-6750-092-H. Table 1 shows the applicability of new and former parts.

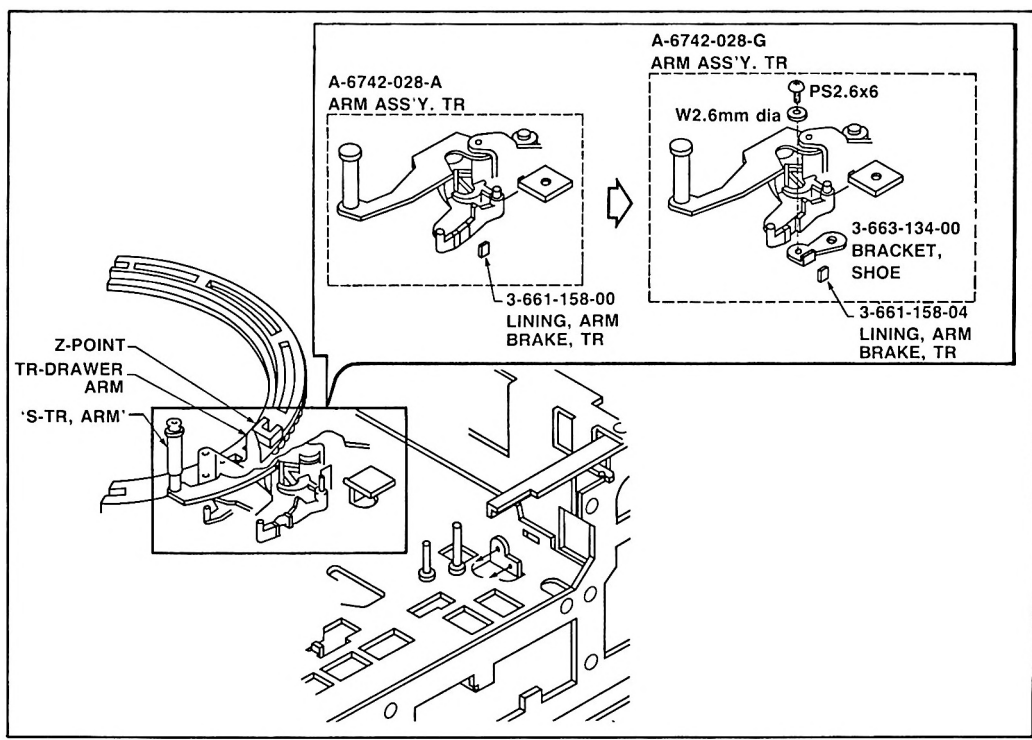
**Figure 1. ARM ASS'Y, TR**

The threading arm assembly ('ARM ASS'Y, TR') has been changed in units with serial numbers 10,811 and higher to allow adjustment for optimal contact between 'TR-DRAWER ARM' and the 'Z-point' of the threading ring. (See Figure 1.) Specifically, this change is to draw out the thread supply arm ('S-TR, ARM') more securely at the threading-end. Perform adjustments on page 3 after the modification is complete.

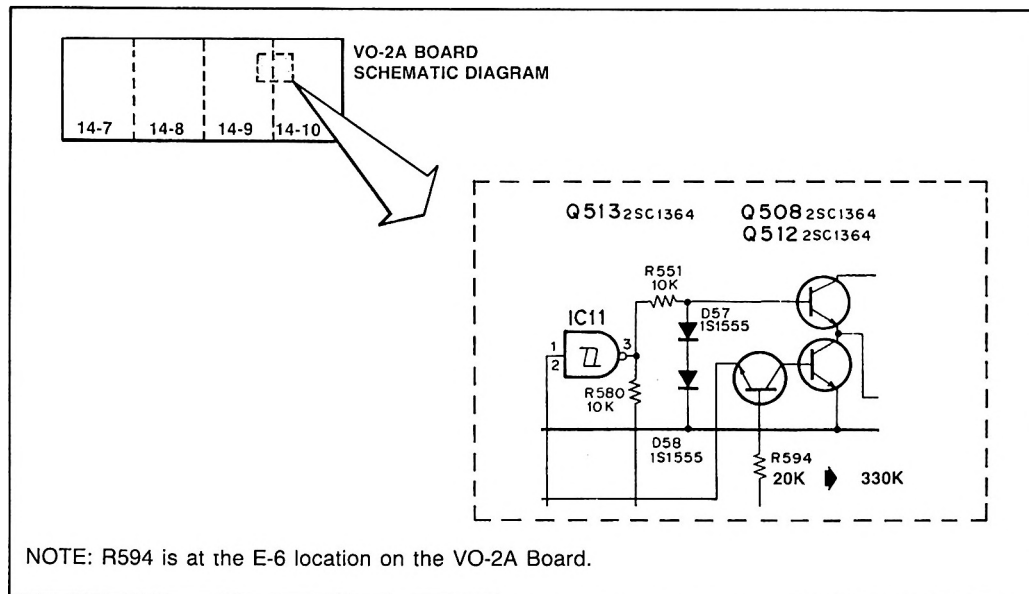
Figure 1

When the PAUSE control is released during playback, color may be lost for more than 5 seconds (normal 1-2 seconds). The problem is caused by the APC circuit on the VO-2A Board. To correct the problem, the value of R594 on the VO-2A Board should be increased from 20k to 330k ohms. (See Figure 1.)

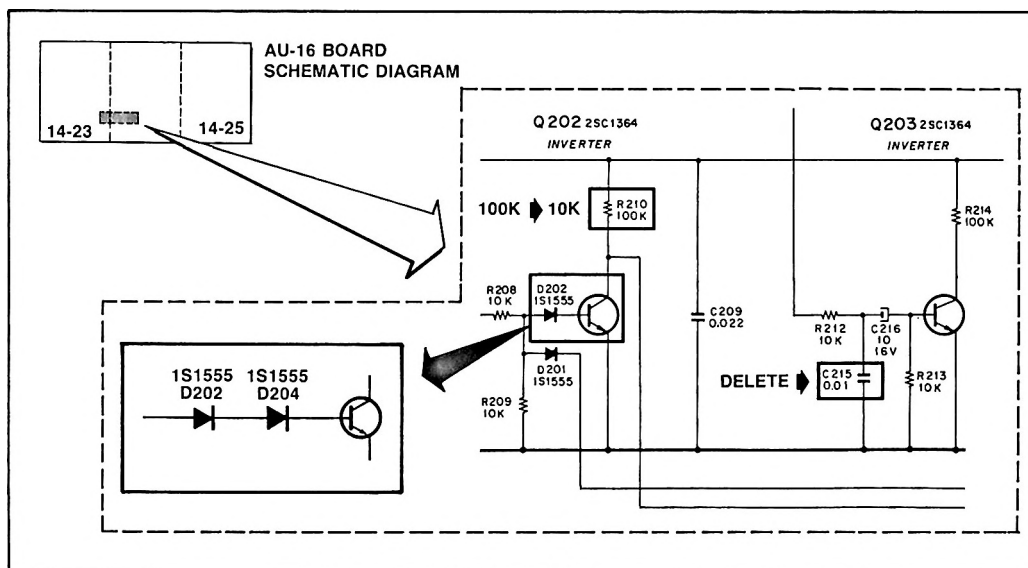
**Figure 1**

The BVU-110 visual warning system sometimes fails to light the RF lamp if the video head clogs during record mode (one or both channels).

The following modifications to the AU-16 Board will eliminate this condition. This modification should be applied when the upper head drum is replaced.

1. Replace R210 (100k ohm) with 10k ohm resistor. (See Figures 1 and 2.)
2. Delete 0.01 $\mu$ F capacitor, C215.
3. Install diode D204 (1S1555) between D202 and the base of Q202.

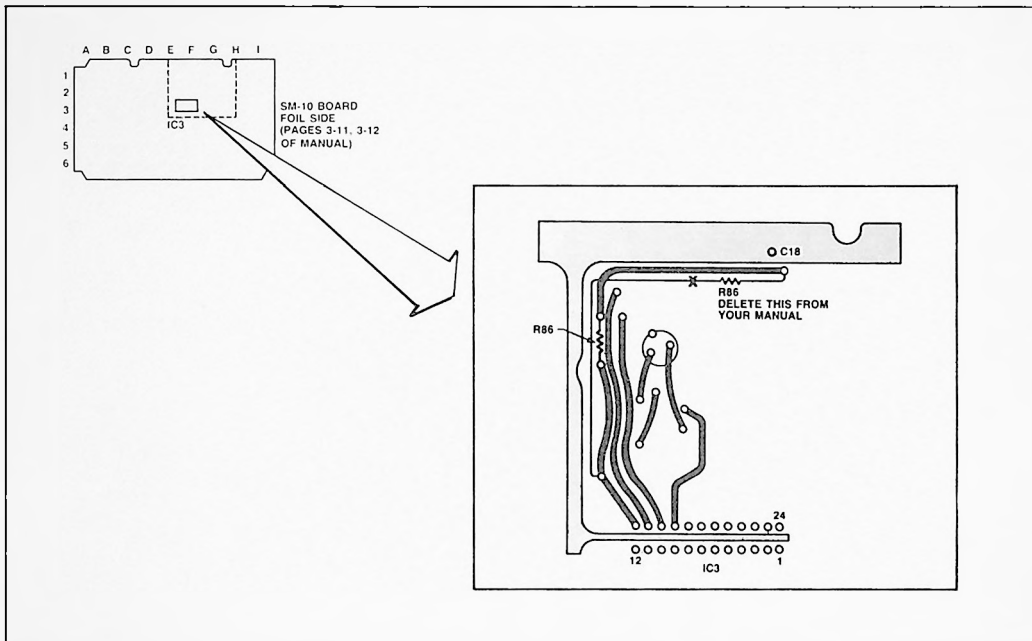
Figure 3

Please correct the SM-10 Board component diagram as shown in Figure 3. (The schematic diagram for this board is correct.)

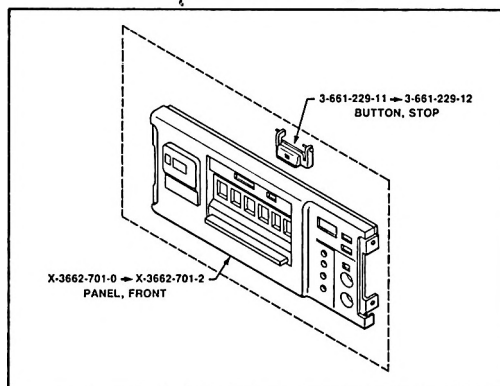
Figure 1.

In earlier units the stop mode could be selected accidentally, by touching or brushing against the STOP button. Beginning with serial number 11,231, a new STOP button has been installed which requires a more positive pressure to engage the stop mode. (See Figure 1.) The new STOP button can be retrofitted on units with serial numbers 10,001 to 11,230. Because the hole pattern for the new button is slightly larger than the old one, a new front panel must be installed as part of this modification.

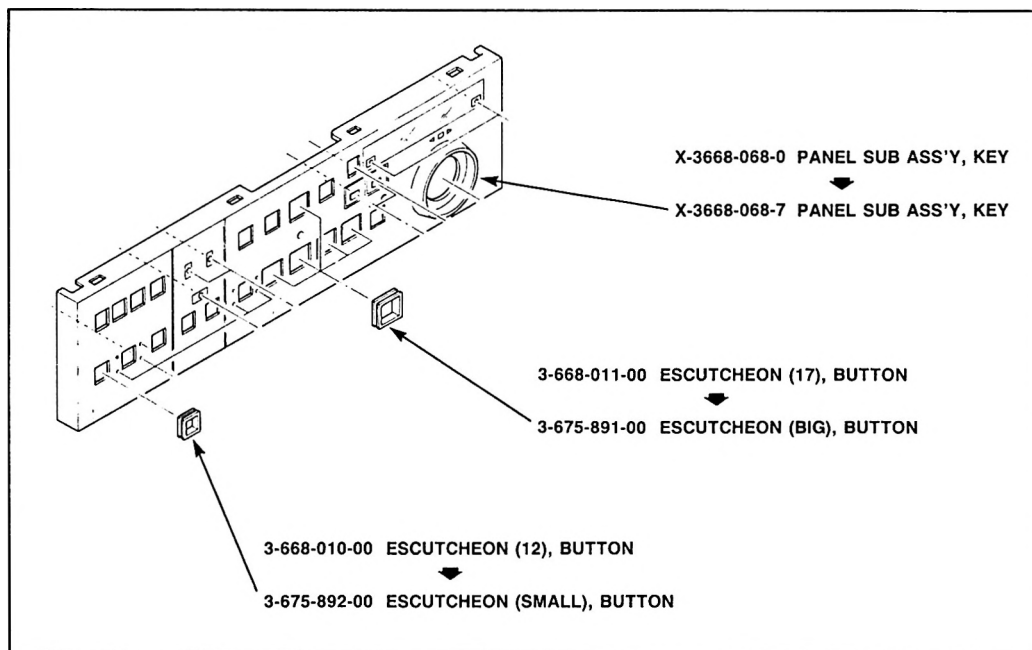
**Figure 1**

The new parts are compatible with all models and serial numbers. However, the new Escutcheons will not fit in the old Panel and the old Escutcheons will not fit in the new Panel. The old parts must be replaced as a set. Figure 1 shows former and new part numbers.

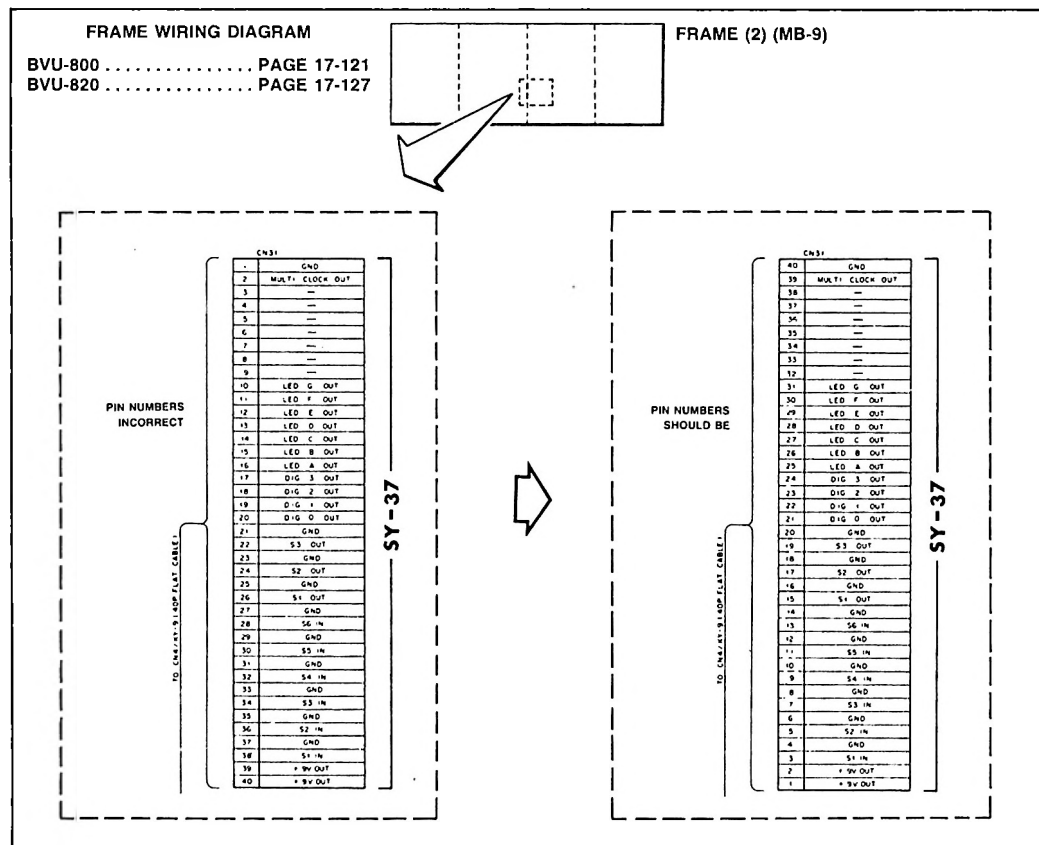
Figure 1

Please make the following corrections (Figure 1) to the Frame Wiring Diagram in the BVU-800/820 Operation and Maintenance Manual, all editions.

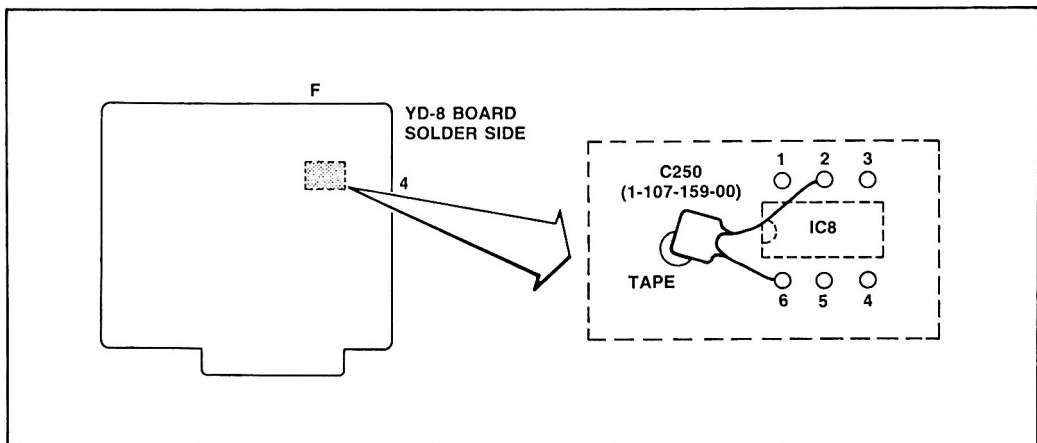
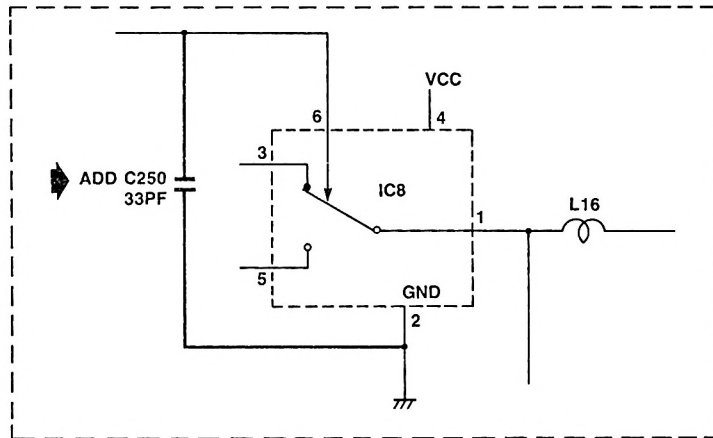
**Figure 1**

**YD-8 Board (See Figures 1 and 2.)**

1. Add new capacitor (C250) between pins 2 and 6 of IC8.

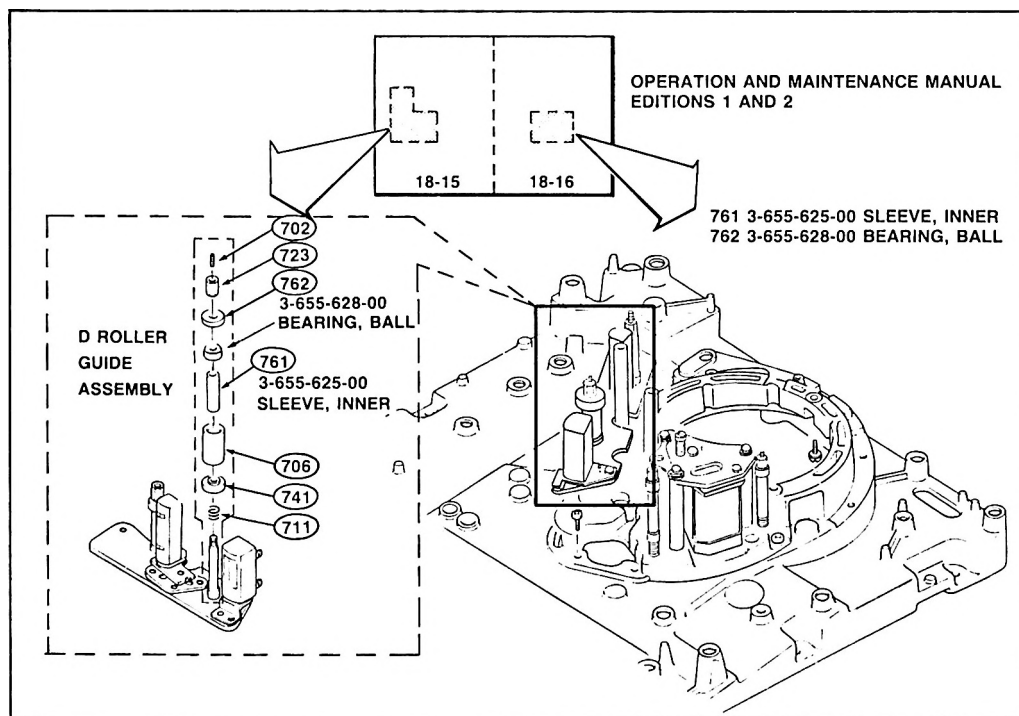
**Figure 1**

For production reasons the "Sleeve, Inner" (3-655-625-00) and "Bearing, Ball" (3-655-628-00) have been added to the D Roller Guide Assembly. (See Figure 1.) Please add the new part numbers to your service manual, 1st and 2nd Edition as shown in Figure 1. (All machines already have these parts.)

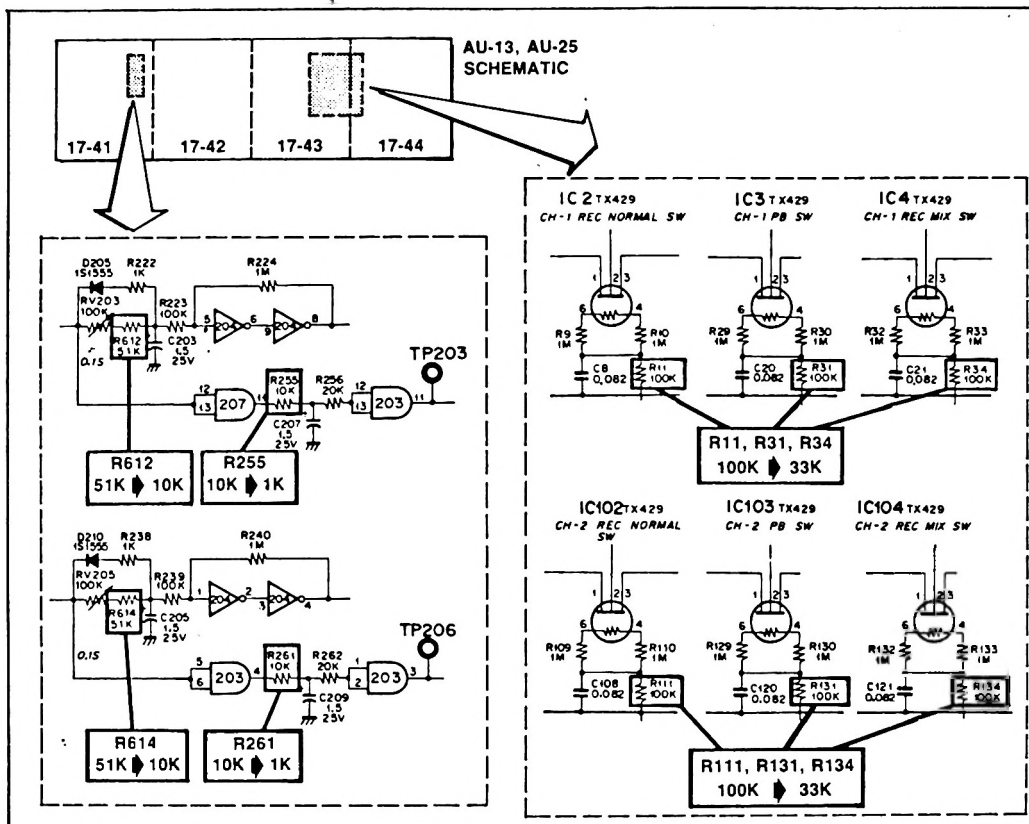
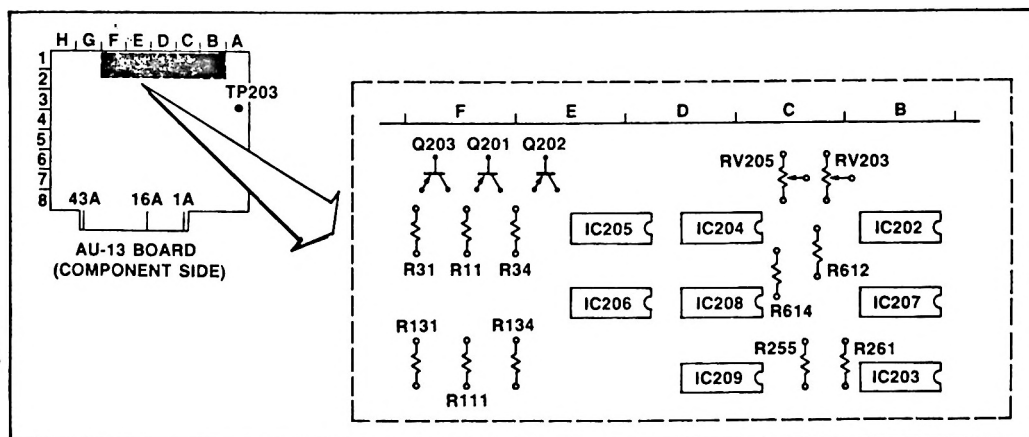
The following modification will improve the audio record timing with reference to video. The Parts Required table lists the resistors that need to be replaced on the AU-13 Board. Figure 1 shows the changes to the schematic and Figure 2 shows the component locations.

1. Replace R255 and R261 with new resistors, 1k ohm, 1/4W, 5%.
2. Replace R11, R31, R34, R111, R131 and R134 with new resistors, 33k ohm, 1/4W, 5%.
3. Perform the adjustments below.
